UNIMPROVED ROADWAY ASSESSMENT & ROADWAY MANAGEMENT PLAN

Prepared for the Town of Montville, Maine

Acorn Engineering, Inc.

April 22nd-23rd, 2025

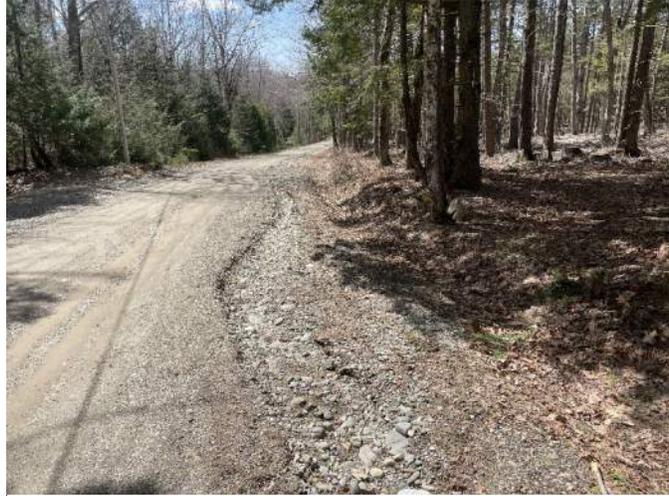
Roadway surface erosion is often the result of surface drainage not being able to access the ditches and running along the surface of the roadway with the direction of travel (longitudinally). Especially in spring, road surface erosion is most likely to occur when rainwater or snowmelt is trapped on the road surface by snowbanks or by berms along the shoulder of the road. During the April 2025 assessment, Acorn observed longitudinal erosion in at least one location on approximately 50% of Town roadways, with the most significant example being on Hidden Valley Road, as shown in the image provided in this discussion section.

Roadway surface erosion, Hidden Valley Road, 4/23/25

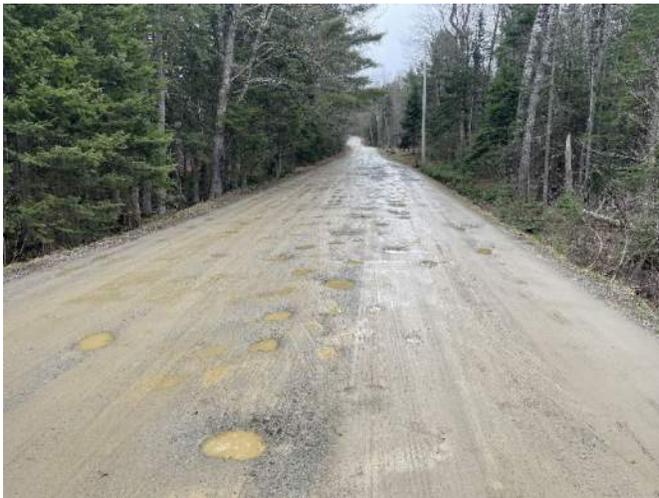
Potholes almost always result from water ponding on the road surface, and are often more severe when the roadway is constructed on poorly drained soils. When water is held on the road surface, vehicles traveling over the road compress the water, and the localized hydraulic pressure disrupts and loosens surface gravel. The use of bank run gravel can exacerbate this problem. Unlike crushed gravel, which has edges and can pack and interlock well, bank run gravel is rounded, allowing tires to easily roll and dislodge the rounded stones out of the road surface, leaving holes that start ponding water and cause compounding pothole problems.

Potholes, Burnham Hill Road, 4/22/25

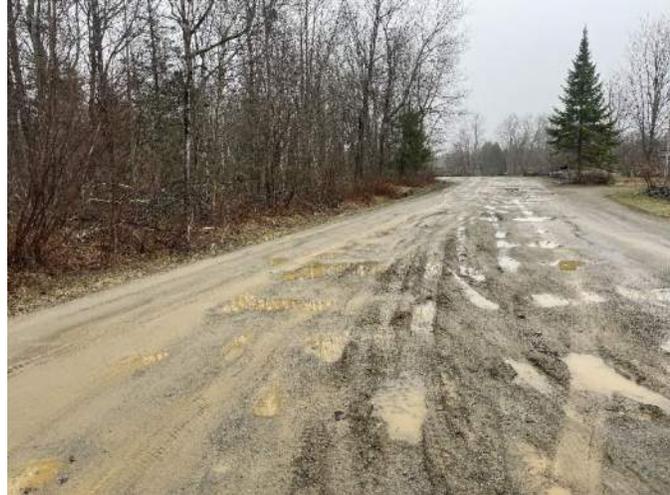
Potholes and ruts, Penney Road, 4/22/25

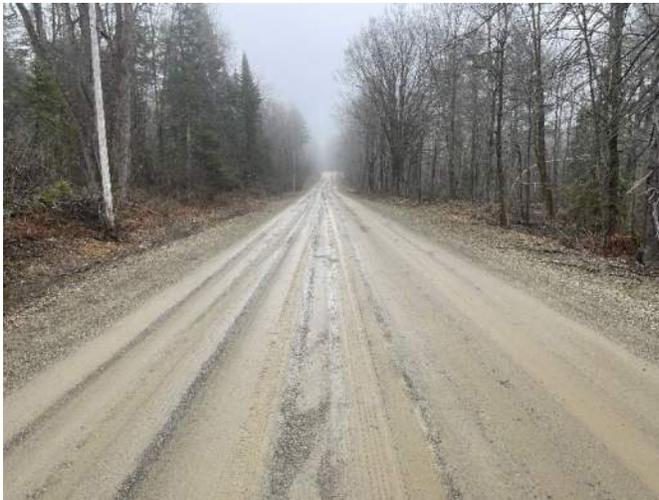
Typical minor ruts, Halldale Road, 4/22/25

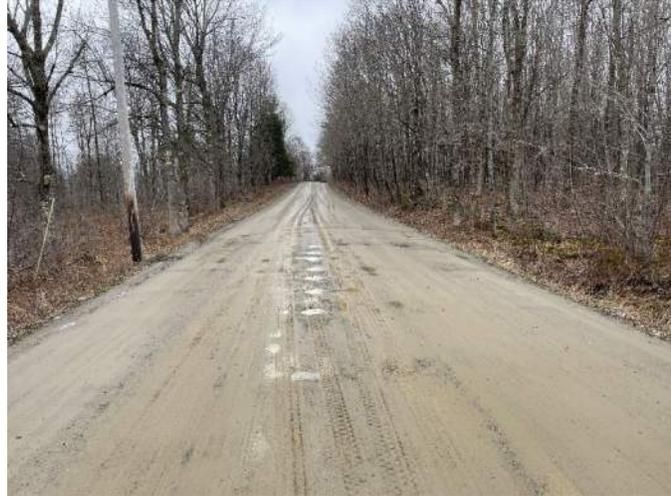
Wide road surface and shoulder absent, Peavey Town Road, 4/22/25

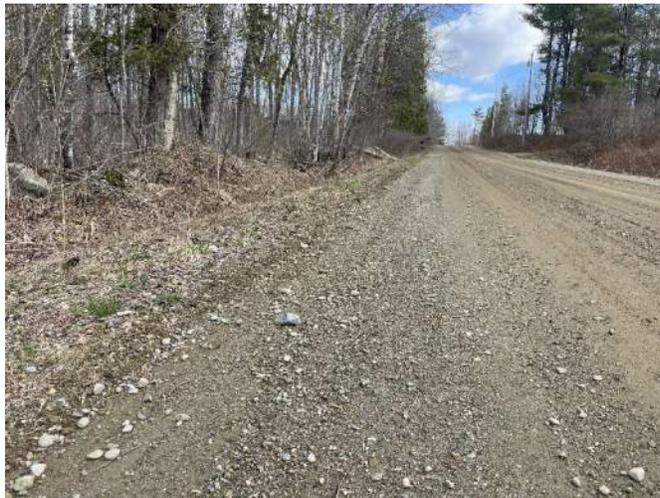
Berm along road shoulder, Choate Road, 4/23/25

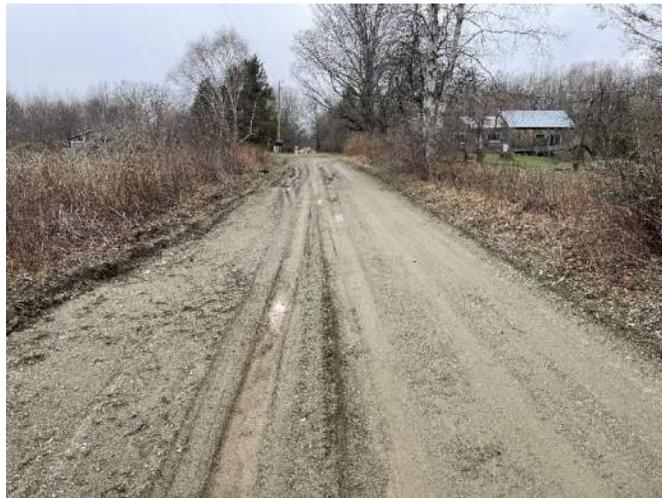
Suggested area to establish ditch (left of photo), road base appeared saturated, Jane's Lane, 4/22/25

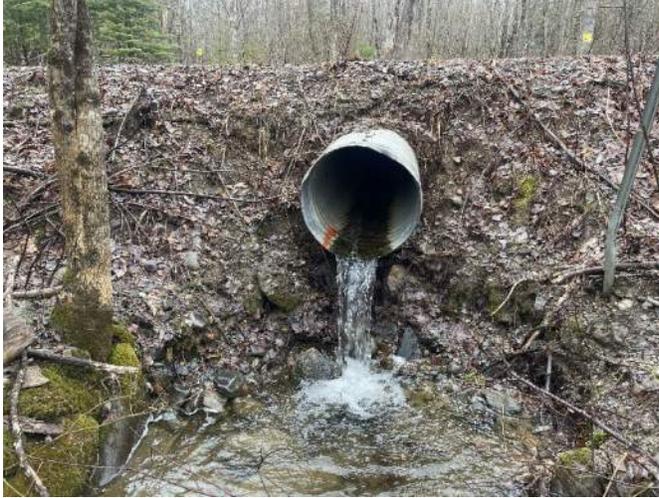
Perched & eroding culvert, Goosepecker Ridge Road, 4/22/25

Culvert outlets should be stabilized with an angular riprap apron extending at least 10' out from the culvert outlet, approximately 5' wide, and should extend up the road or driveway shoulder above the top of the pipe. Angular riprap is preferred due to its ability to interlock, as compared to bank run stone, which is rounded and easily dislodged by gravity and runoff. Riprap should be generally 6" in average dimension, and larger at steep areas or areas subject to intense flow. Recently constructed and adequately-sized riprap aprons were observed during the Assessment at some locations, but in general were composed of bank run stone and were beginning to erode. Acorn recommends that the Town prioritize the use of angular stone when stabilizing culverts in steep or high-flow areas. At gentler grades, bank run stone may be used as a cost saving measure to afford some level of protection. Stabilizing culvert inlets is also recommended and may be conducted at the Town's discretion. Various culvert maintenance recommendations are provided in the individual roadway discussions and in the supplemental maps.

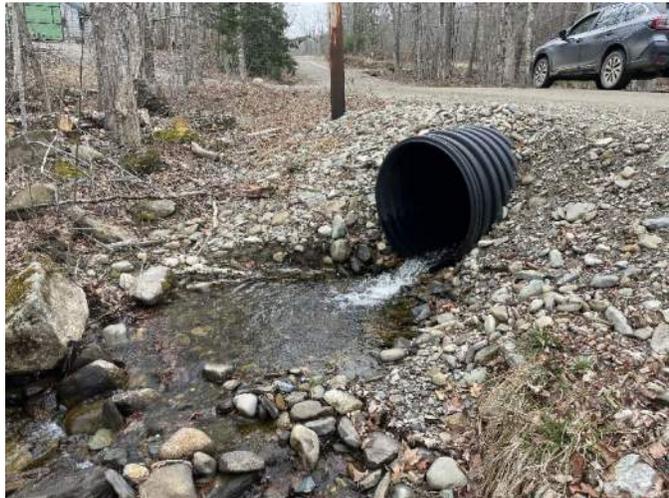
Bank run outlet stabilization exhibiting initial erosion, Haystack Mountain Road, 4/22/25

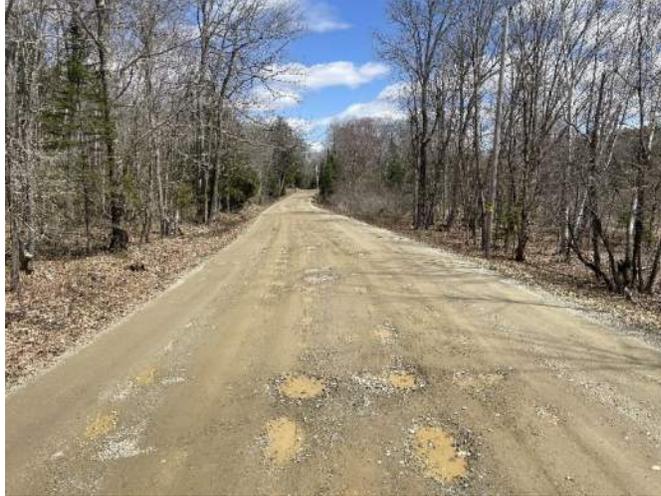
Area of recommended resurfacing, Morrill Road, 4/23/25

Roadway resurfacing should be conducted when the existing surface gravel has been lost, eroded, displaced, or no longer has the appropriate distribution of particle sizes (gradation) to properly interlock/compact and to effectively drain. The need to resurface is most evident when a portion of road exhibits recurring dense potholes, washboards, or loose aggregate on the surface. These signs can indicate that the surface gravel is poorly blended and that fines have been blown or eroded from the surface, reducing the surface material’s ability to self-bind. Additionally, the emergence of larger diameter aggregate at the road surface can indicate that surface gravel coverage is thin, and base gravel, which

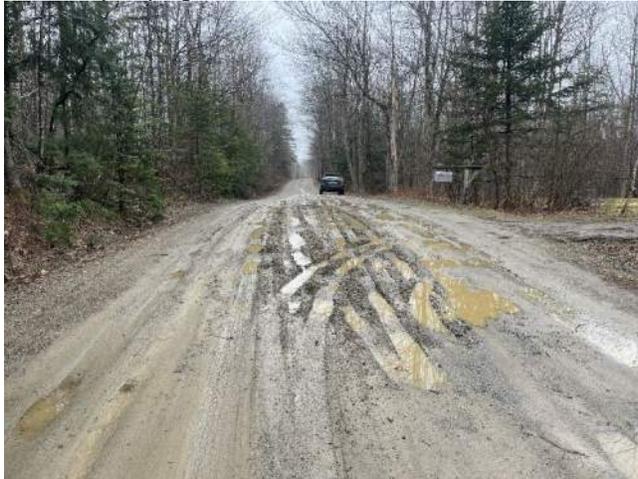
Area of recommended spot reconstruction, Goosepecker Ridge Road, 4/22/25

Roadway reconstruction should be conducted at the Town’s discretion where the existing base gravels are known to be absent, of poor quality, or are unable to adequately support traffic loads. Base failure may indicate a road is at the end of its life cycle, is contaminated with poor-quality native soils, or has historically poor drainage and is saturated – or a combination of all factors. The need to reconstruct is most evident when a portion of road exhibits recurring deep ruts and “pumping” of the native soils and moisture to the surface. These signs are most apparent in the spring of the

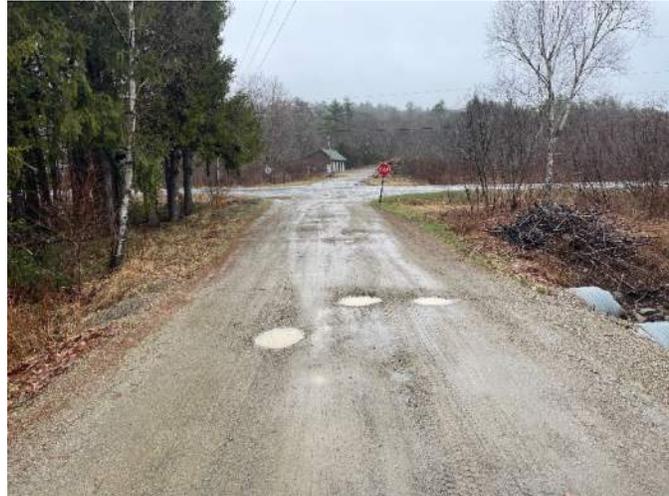
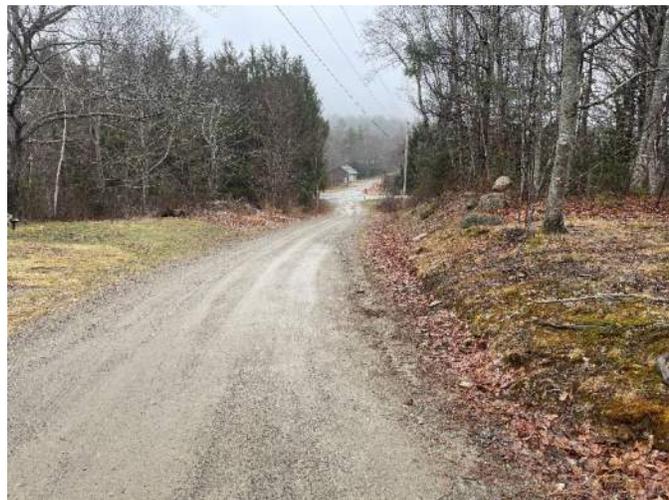
In general, Bean Road is characterized by rolling running slopes and a flat roadway cross-section, and minimal crown and ditching were observed at the time of inspection. The road serves approximately 3 residences, and minor ruts and potholes were observed. Minor erosion was observed along the south shoulder of the road east (downhill) of the driveway to address #16.

Bean Road at Bartlett Stream crossing, looking east

Bean road, looking east near #16 driveway

Bean Road should be regraded to reestablish a strong crown and improve surface drainage. During grading, any berms at the shoulders should be cleared to allow water to completely drain from the road surface. Additionally, Acorn recommends that approximately 200 LF of the roadway - from Rt. 220 across Bartlett Stream, be resurfaced with 4-6" of suitable surface gravel, crowned, and roller-compacted to reduce potholes. Finally, Acorn recommends that a ditch be created along the south side of the road from address #16 downhill toward Bartlett Stream to reduce erosion in the roadway.

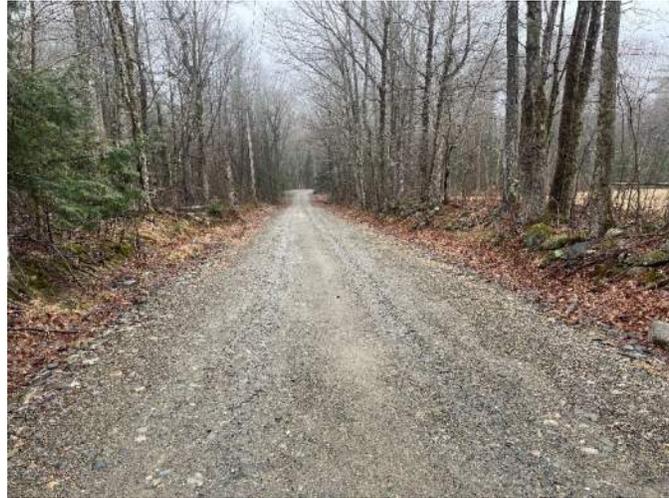
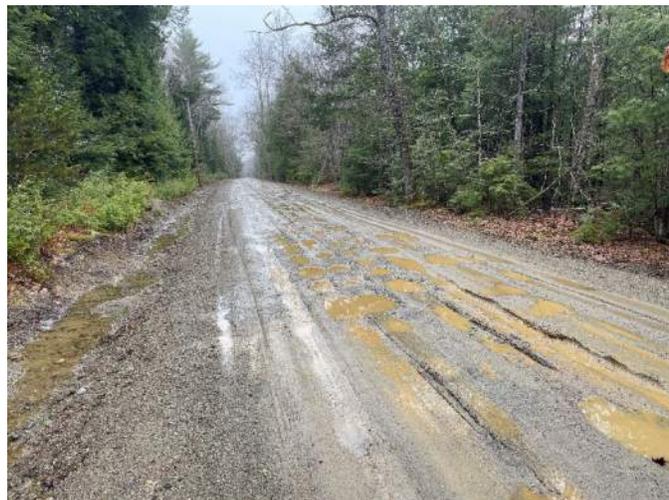
In general, Berry Road is characterized by rolling to steep running slopes and a crowned but interrupted roadway cross-section and serves approximately 2 residences. The first 0.7 miles of road contain numerous flat sections with limited slope along the direction of travel. Acorn observed that portions of Berry Road had recently been ditched, with ditch depth variable and shallow in some locations. Excessive ruts and potholes were observed at the time of inspection, and due to the severity of ruts, it is evident that the roadway base was saturated or was still frozen. The road is generally wooded along both sides and appears to receive limited sunlight.

Berry Road at approx. mile 0.3, facing north. Shallow ditch present

Berry Road should be regraded to reestablish a strong crown and improve surface drainage. It is likely that the recent ditching has improved road conditions, however deeper ditches should be created to better drain the road base. The driving surface was wide and, as appropriate to low traffic volume, could be narrowed and raised to create a higher road with deeper ditches to fit within the Town's ROW. The Town may consider reconstructing approximately 0.3 miles of roadway in the wettest, middle section with new base and surface gravels, which may be underlain by woven geotextile fabric to separate the road from the poorly drained native soils. The roadway is generally shaded and tree clearing is recommended, in coordination with landowners as needed, to hasten drying during spring thaw, primarily in the wettest, middle 0.3-mile section of road.

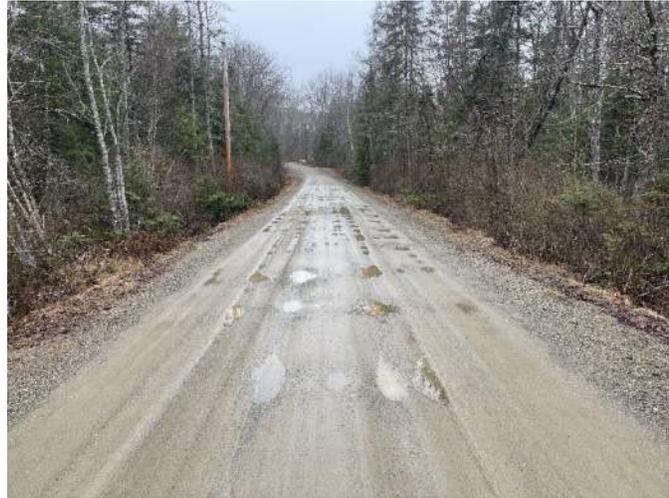
In general, Bragdon Road is characterized by flat to rolling running slopes, with a steep section near the road's end. Roadway cross section is generally flat, especially near Rt. 220 and west of the hairpin turn. Minor ruts and moderate potholes were observed at the flat sections of road, and minor erosion was observed near steep sections at the hairpin turn and at the road's end. It was evident that surface material has been pushed to the shoulders and ditches, possibly during winter plowing activities.

Bragdon Road looking north, at low section of road west of hairpin turn

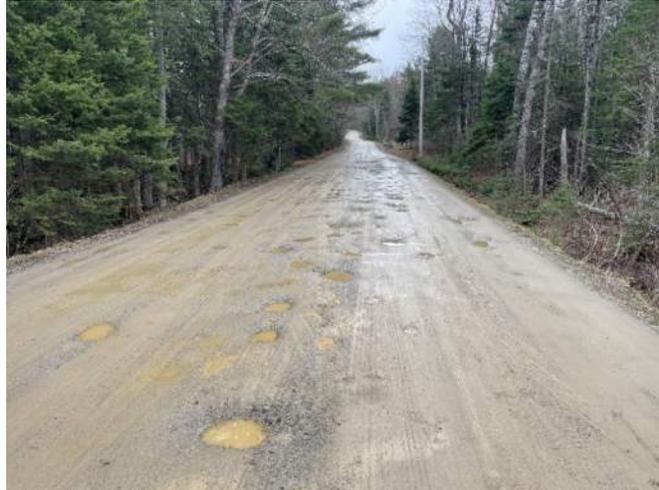
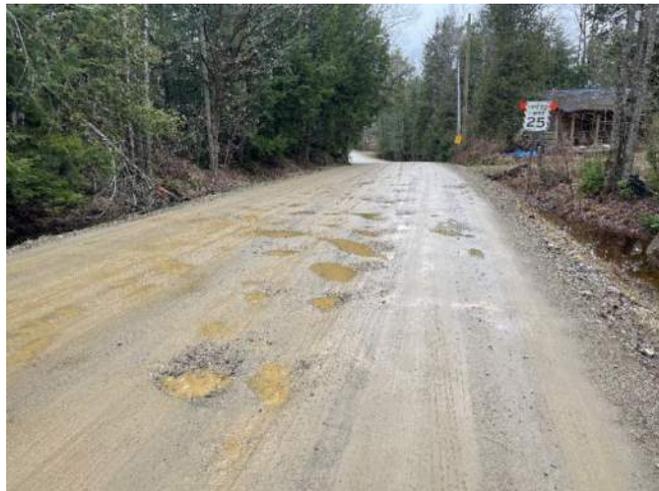
In general, the gravel portion of Burnham Hill Road is characterized by flat to rolling running slopes and a flat roadway cross-section, and minimal crown was observed at the time of inspection. Advanced potholes were observed along much of the road. Much of the roadway, which is wide, is elevated above surrounding grade or ditched. It was evident that surface material has been pushed to the shoulders and ditches, possibly during winter plowing activities. Additionally, it was evident that users travel this road at a higher rate of speed than is desired, hastening pothole formation.

Burnham Hill Rd., typical pothole severity and road width

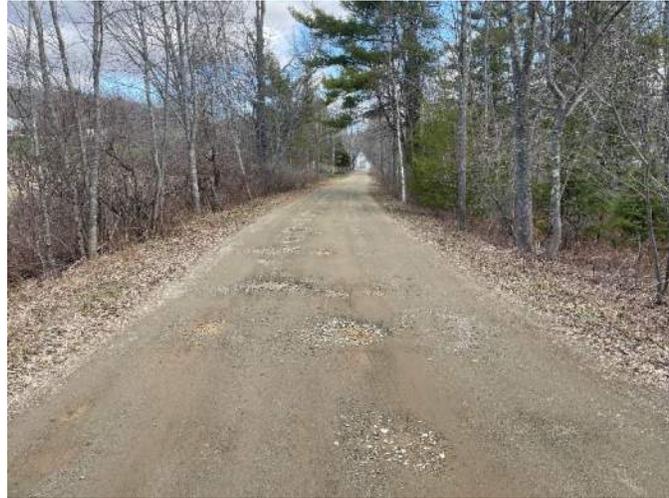
In general, Cemetery Road is characterized by flat running slopes and a flat roadway cross-section, and minimal crown and ditching were observed at the time of inspection. Moderate potholes were observed in some areas, with much of the road in fair condition. It was evident that surface material has been pushed to the shoulders, possibly during winter plowing activities.

Cemetery Road, typical view.

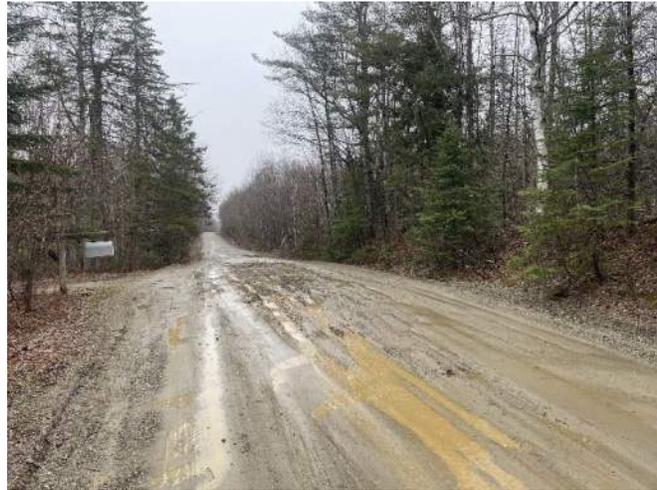
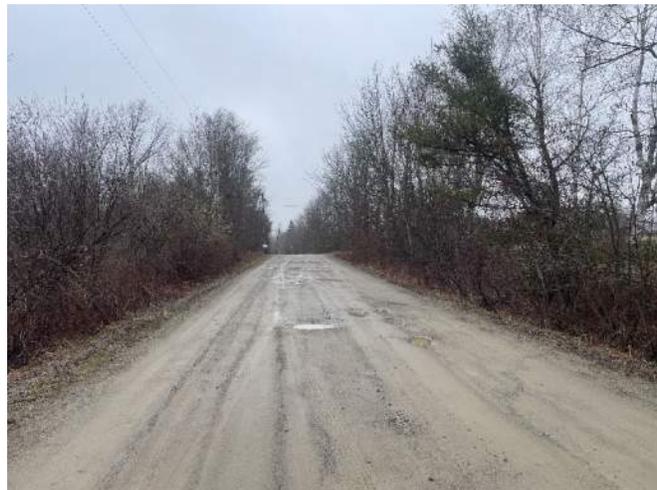
In general, Goosepecker Ridge Road is characterized by flat to rolling running slopes and a flat roadway cross-section; minimal crown was observed at the time of inspection. The road was in overall poor condition at time of inspection, with advanced potholes observed along much of the road. Much of the roadway, which is wide, has shallow, woody ditches, and is poorly drained. It was evident that surface material has been pushed to the shoulders and ditches, possibly during winter plowing activities.

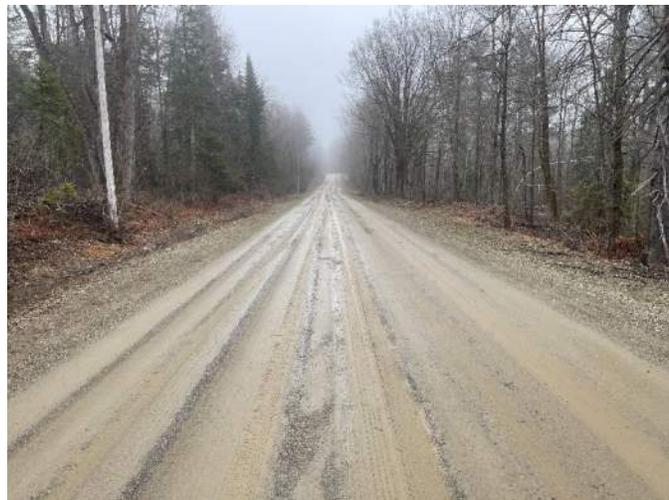
Halldale Road looking south, typical condition.

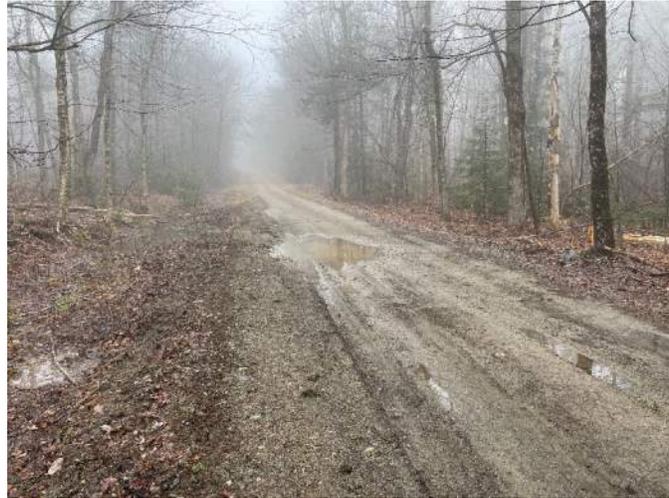
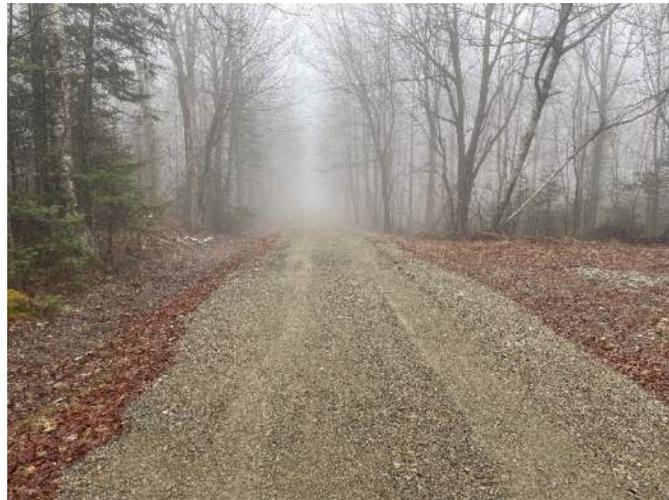
After a steep climb in the first quarter mile, Howard Road is characterized by rolling running slopes and has a flat cross-section; minimal superelevation was observed at the time of inspection. Moderate to advanced potholes and ruts were observed in some areas, particularly in the first half mile of road, which was in generally poor condition and is level with or below surrounding grade. Acorn understands the Town has recently invested in resurfacing and drainage improvements at the last half mile of road, and this section of road was observed in fair condition. Surface material has been pushed to the shoulders and ditches, likely during plowing activities, creating a bermed shoulder and interrupting positive surface drainage.

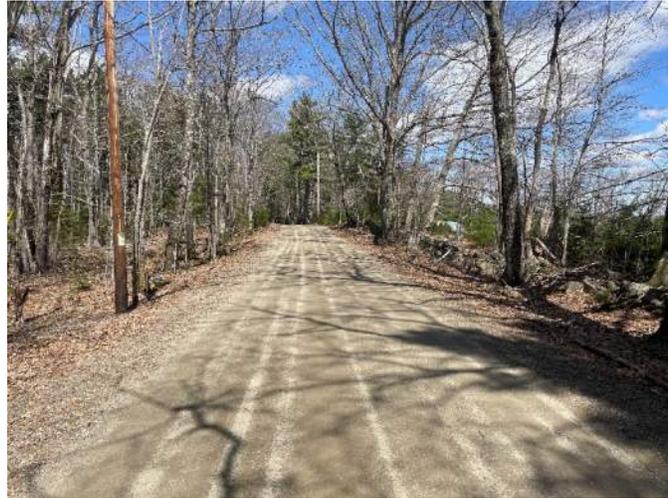
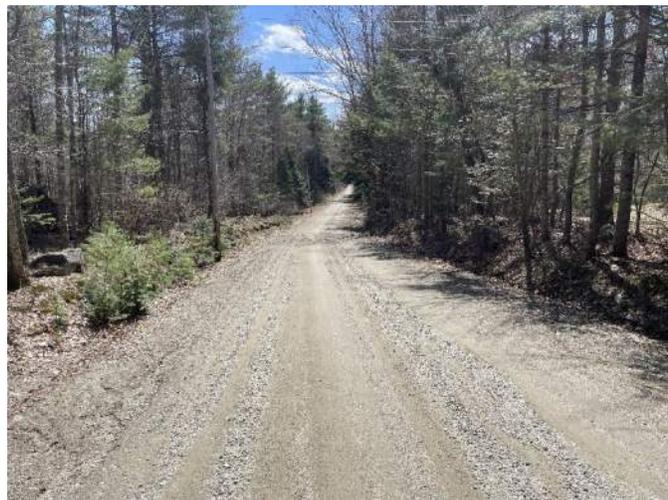
Howes Road is characterized by flat to steep running slopes and a flat roadway cross-section, and minimal crown was observed at the time of inspection. Ditching was generally present, but was wooded and generally shallow, due to localized ledge, especially along the upper section of road. Ruts and longitudinal erosion were observed at the time of inspection, and it is evident that spring runoff could not access the ditches.

Howes Road looking south along climb, erosion and ruts present

Howes Road should be should be regraded to establish a strong crown, and roller compacted. Regular shoulder maintenance should be performed and regular ditch maintenance should be conducted to clear and reestablish the run of the ditch, remove woody vegetation, and increase snow storage capacity. At steeper sections, angular riprap may be installed to stabilize ditches >10% running slope and discourage erosion. Along both sides of Howes Road, reestablishing a deep ditch may require ledge removal in some areas, namely near the top of the last climb on the road. In lieu of creating a deeper ditch, the driving surface could be narrowed as appropriate to low traffic volumes and raised above grade with 6-8" of suitable surface gravel. It may be possible with a grader to salvage surfacing gravel which has been pushed into the shoulders and ditches to reduce material import. The roadway is generally exposed to sunlight and tree clearing is not a critical maintenance recommendation.

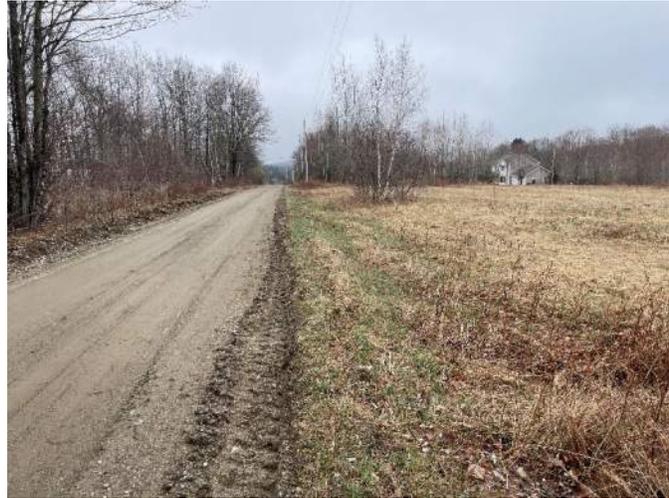
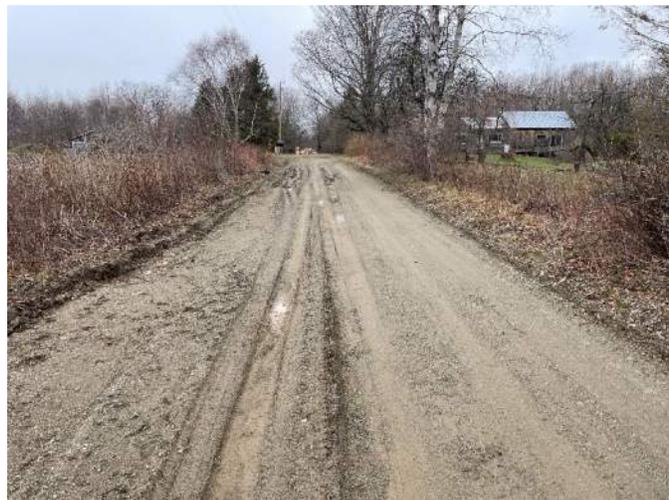
Janes Lane looking south, typical shoulder condition

Janes Lane looking south, typical ruts

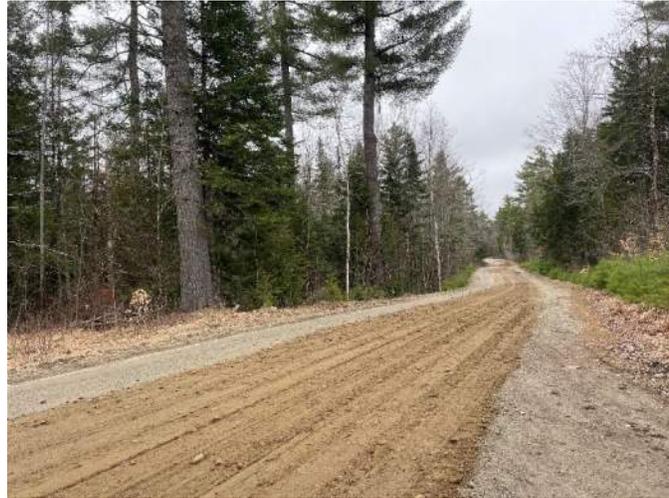
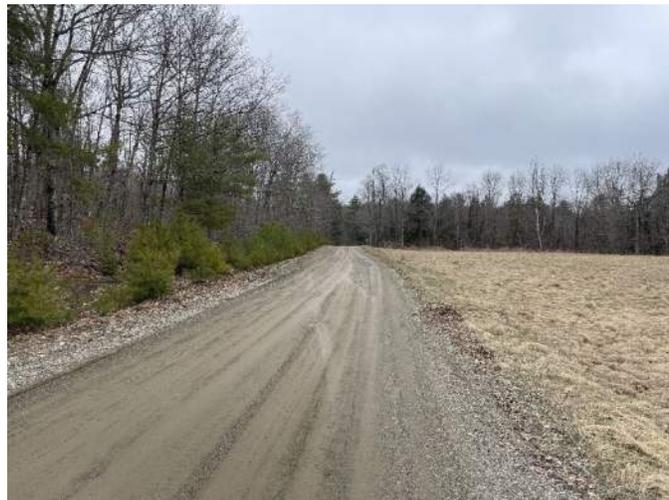
Kingdom Road lies in south Montville, extending north 1.83 miles from Route 3 to the end of Town maintenance at the Robbins pit entrance. Kingdom Road is characterized by rolling running slopes and a flat roadway cross-section, and minimal crown was observed at the time of inspection. Ditches were generally shallow and ranged from clear to brushy. Numerous sections of minor potholes existed along the length of the road at the time of inspection, and the road base appeared generally strong and well-drained. Two areas of road were observed acting as a dam, and cross culverts were absent in these areas. One cross-culvert approximately 1.25 miles north of the Route 3 intersection was beginning to collapse, and had <12" of cover.

Kingdom Road looking south, typical resurfacing by others

Resurfacing of numerous areas along Kingdom Road was ongoing by others at the time of inspection to address potholes and washboards. This road is subject to regular heavy truck traffic from the active gravel pit at the end of the road, and it is Acorn's understanding that maintenance observed at the time of inspection was being conducted by entities associated with the gravel pit as a good-faith effort to maintain the road critical to their operations. Overall, the road was observed in fair condition.

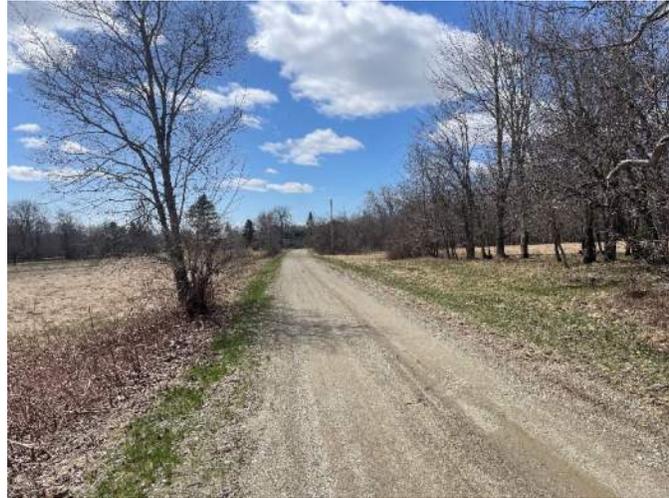
In general, Lefty Lane is characterized by flat running slopes and has a flat cross-section; minimal crown or superelevation was observed at the time of inspection, and much of the road's length sits below the road shoulders, with ditches absent. Surface material has been pushed to the shoulders, creating a bermed shoulder and interrupting surface drainage.

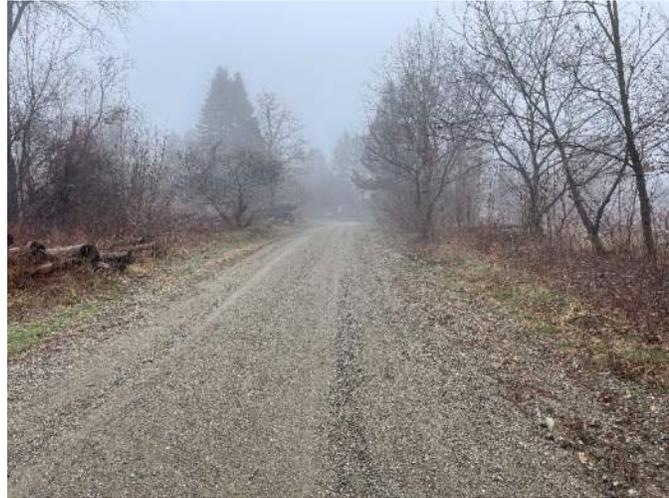
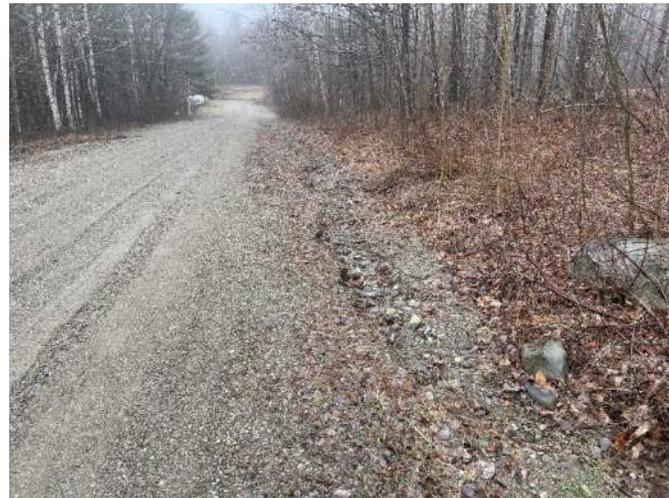
In general, Martin Road is characterized by steep running slopes and a fair roadway cross-section; some crown and superelevation were observed at the time of inspection. The road is wide and minor erosion was observed in the roadway surface and shoulders, running downslope and with the direction of travel. Ditches were shallow or heavily vegetated along much of the roadway's length, and surface gravel had been pushed to the shoulders and ditches.

Martin Road looking north, minor surface erosion observed

Martin Road looking south, minor shoulder erosion observed

Ditches should be reestablished along the east side of the road at its northerly end, and along the west side of the road along the central and southerly end. The driving surface is wide and, as appropriate to low traffic volumes on this road, could be narrowed to allow deeper ditches to be constructed within the Town's ROW, which may allow snowmelt to access the ditches. Where ditches exceed 10% running slope, angular riprap may be installed to stabilize ditches and discourage erosion. Ditch turnouts, stabilized with riprap and a stone spreader, may be installed every 100 LF where possible, and coordinated with adjacent landowners. The roadway is generally exposed to sunlight and tree clearing is not a critical maintenance recommendation.

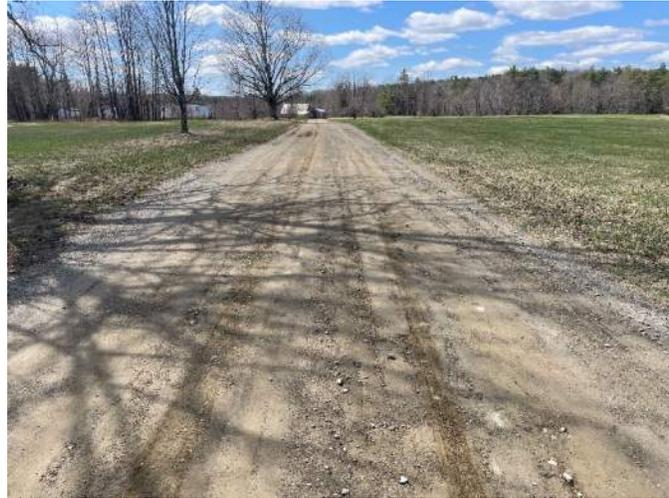
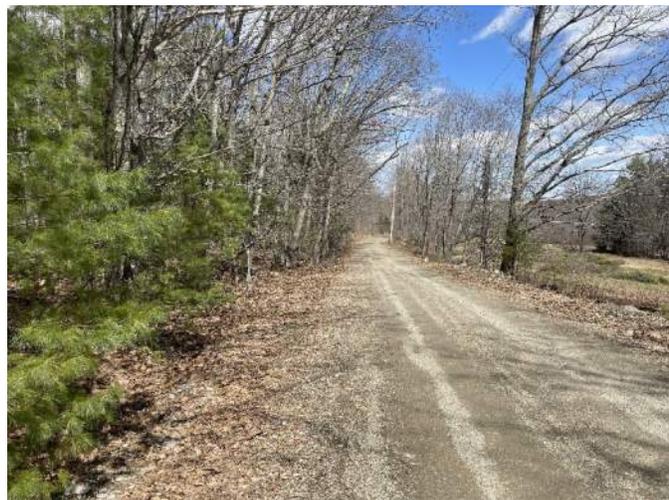
In general, Mehuren Road is characterized by flat to rolling running slopes and a flat or inwardly-draining roadway cross-section; minimal crown and ditching were observed at the time of inspection. Moderate ruts and potholes were observed and numerous sections of road sit below surrounding grade. It was evident that surface material has been pushed to the shoulders, possibly during winter plowing activities, and that water is held on the road surface. Additionally, a ~100 LF section of severe potholes was observed just west of the Bartlett Stream bridge crossing.

Mehuren Road looking northeast, minimal ditch along west of road

The northernmost 0.6 miles of Mehuren Road should be resurfaced with 6-8" of suitable surface gravel to raise the road surface elevation, graded to establish a strong crown, and roller compacted. Along the entire road, bermed material along the shoulders should be removed to allow water to drain off the roadway surface, and ditches should be maintained and deepened where surrounding grades allow to improve drainage of the road base and reduce rutting. The ditch along the west side of the road for the southern 0.33 miles of the road should be reestablished and cleared of vegetation.

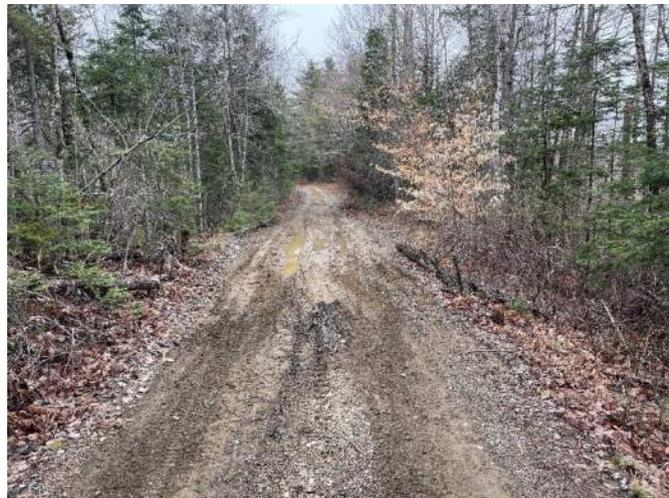
Peavey Town Road, end section, typical ruts

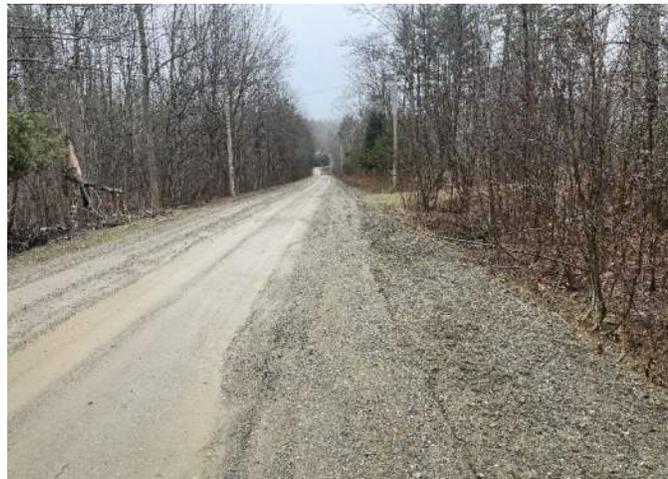
Penney Road looking south, shoulder erosion present south of Grant Rd.

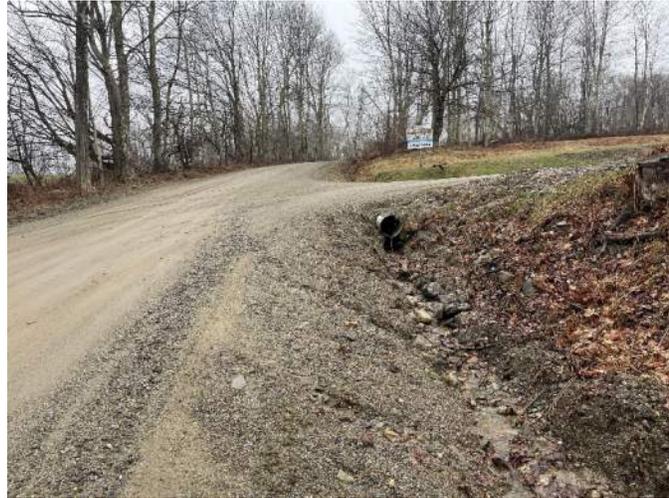
Randlett Road looking west, typical perched culvert and ditch erosion

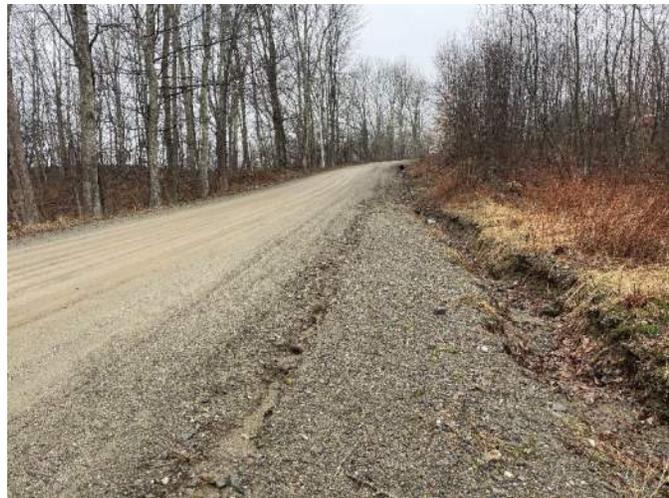
Randlett Road looking west, typical ditch erosion

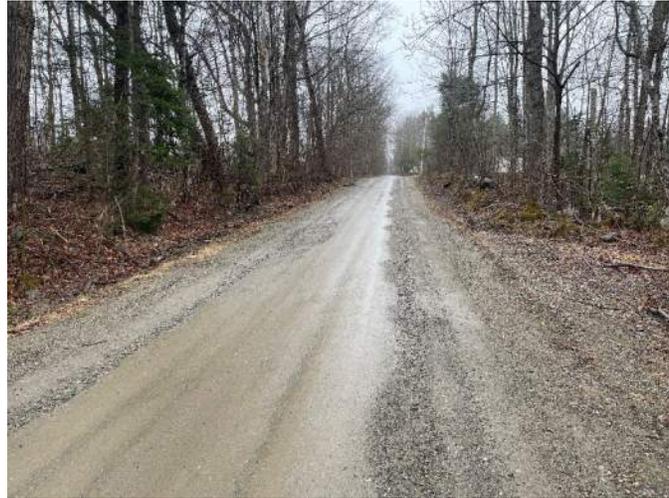
Stewart Road looking east, typical longitudinal erosion

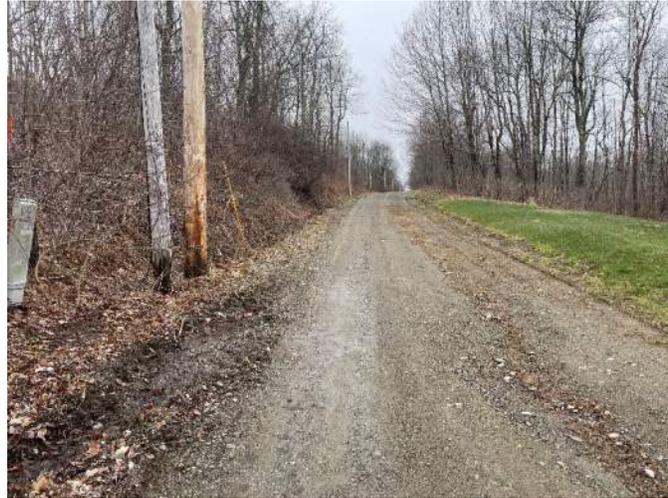
Thompson Road looking west, typical ditch condition

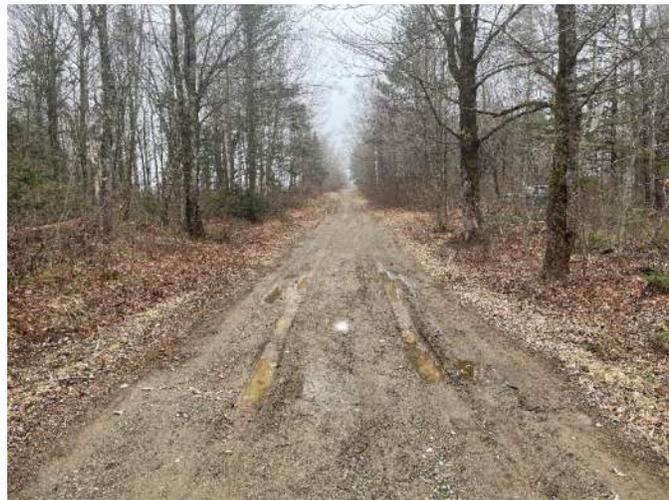
Twitchell Hill Road, end section, typical view of road constructed on poor native soils.
