UNIMPROVED ROADWAY ASSESSMENT & ROADWAY MANAGEMENT PLAN

Prepared for the Town of Montville, Maine

Acorn Engineering, Inc.

April 22nd-23rd, 2025

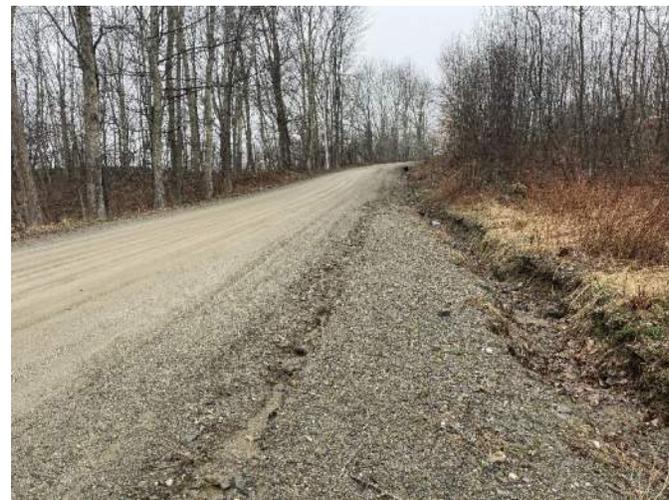
Newly-maintained ditch side slopes should always be stabilized with mulch/straw and seed, erosion control blankets, erosion control mix, or riprap to stabilize the ditch as soon as possible. Ditches are most stable when they are cut in a u-shape (as opposed to v-shaped), and if possible, side slopes should not be steeper than a 2 horizontal to 1 vertical ratio (not more than half as high as they are wide). Steep slopes are prone to collapse and are difficult to establish with vegetation. If steeper side slopes are necessary, they should be stabilized with riprap. Angular/crushed products are preferred due to their ability to interlock, versus rounded, bank run stone due, which is susceptible to movement. During the April 2025 assessment, Acorn observed evidence of recent ditching on Goosepecker Ridge Road, Berry Road, and Peavey Town Road, with evidence of side slope erosion and no evidence of stabilization, mulch, or seed applied to the exposed soil.

Ditch channel erosion, Randlett Road, 4/22/25

In the channel bottom, grass stabilization is typically adequate for ditches with running slopes <5%. Where slopes exceed 5%, angular stone is preferred to protect the channel bottom from erosion, but erosion control blanket may be used to help stabilize the ditch before grass is established. All ditch channels >10% should receive angular riprap to protect the ditch from downcutting. Riprap should be generally 6" in average dimension, and larger at steep areas or areas subject to intense flow. In areas of significant slope or recurring erosion, stone check dams composed of angular riprap may be installed to slow water, but these must be maintained annually to remove sediment and reset any dislodged stones. When ditch maintenance is conducted, ditches along Halldale, Morrill, Twitchell Hill, North Ridge, Choate, Hidden Valley, Hogback Mountain, Haystack

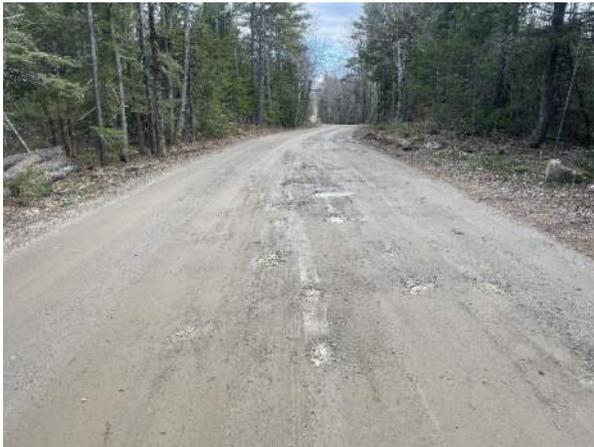
Flattened roadway cross section, North Ridge Road, 4/23/25

During the April 2025 assessment, Acorn observed that approximately 85% of the network's road miles had inadequate cross slopes, possibly exacerbated during winter maintenance by snowplows. Of note, although spring grading had recently been conducted on Choate Road at the time of assessment, Acorn observed cross slopes and crown less than the recommended $\frac{1}{2}$ " per foot, or 4%. Evidence of recurring potholes was also observed, suggesting the recent grading may not have cut the surface gravel deep enough.

Flat road cross sections contributed to potholes most notably on the Town's highly-traveled through roads. While grading occurs, special attention should be paid to removing surface deformations, establishing the recommended 4% minimum cross slope, and compacting the graded surface.

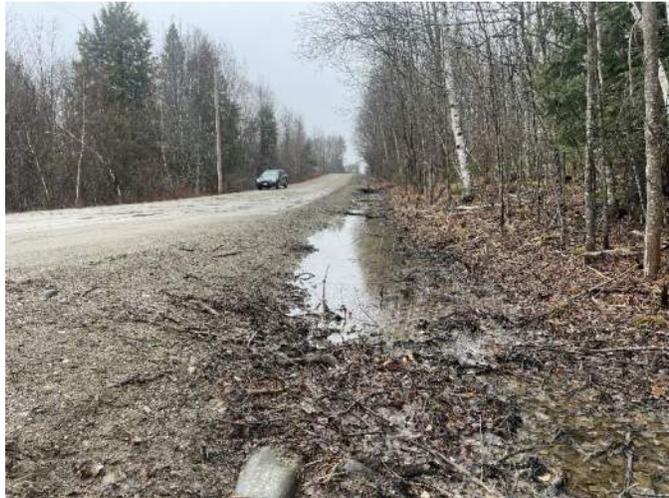
Debris in ditch holding water, Goosepecker Ridge Road, 4/22/25

Where the ditch is overgrown with thick, woody vegetation or is holding water in some areas, typical maintenance requires re-excavation of the ditch to remove woody growth and roots and clear the channel bottom of all berms, lumps of material, and any other hindrances to flow. When clearing ditches, a smooth edge bucket should be used to ensure smooth side slopes and channel bottom. Toothed buckets create ridges perpendicular to the direction of flow, holding water. Channel running slopes should ensure the ditch is free-draining, and maintenance may require re-cutting as discussed in the “Establish or deepen ditch” section above to ensure free drainage. Fresh excavation should always be stabilized as described in the “Ditch Erosion” section above.

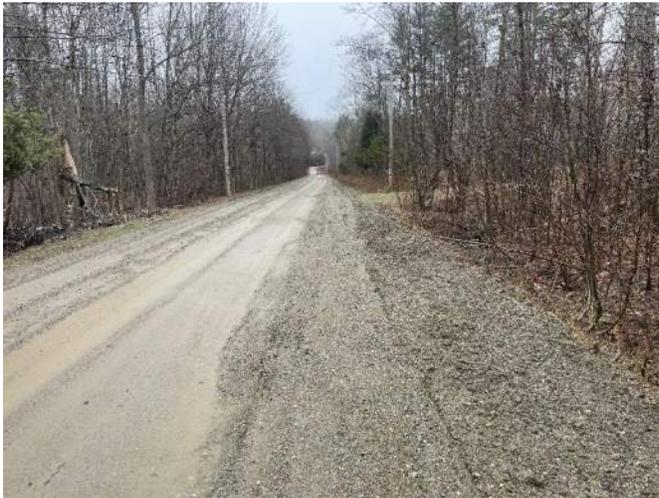
Woody debris in ditch, Penney Road, 4/22/25

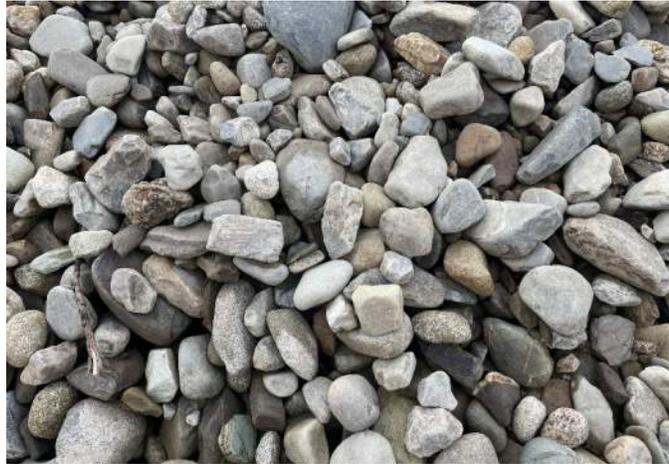
Stockpile of 2-6" screened stone suitable for crushing, Halfmoon Pit, 4/4/25

The dominant parent material of the glacial deposits in the bank-run pits appeared to be durable igneous and metamorphic stone, and the Town should continue to use material from these pits, provided the material is screened and crushed prior to blending and placement. Processing and blending Town-owned material may provide cost savings as compared to purchasing material from outside sources. The bank-run material should be screened to segregate various size ranges (e.g. 2-3" stone, 3-6" stone, 6-8" stone, 12"+ stone) suitable for crushing, secondary screening, and incorporation in base gravel, surface gravel, and riprap products.

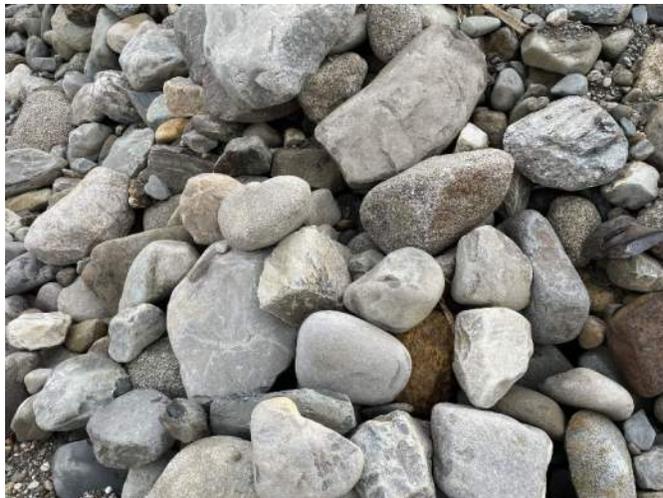
Stockpile of 12"+ screened stone suitable for crushing, Halfmoon Pit, 4/4/25

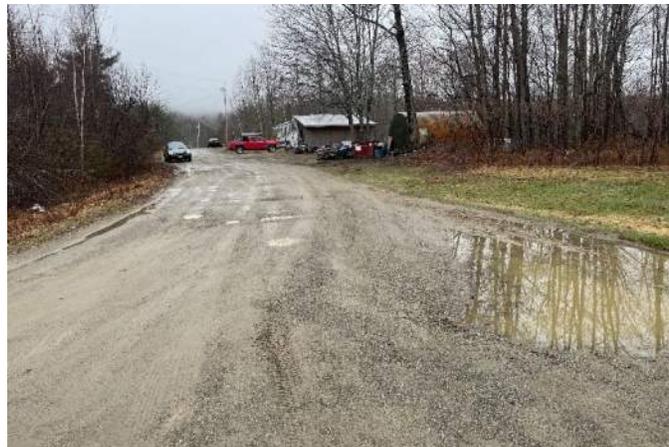
Bragdon Road looking west at Rt. 220 intersection.

In general, Bragdon Road should be regraded to reestablish a strong crown, or to establish superelevation at sharp corners, to improve surface drainage. Routine ditch maintenance should be conducted to reestablish deep ditches and to clear debris and vegetation. For approximately 200 LF at the intersection with Rt. 220, Acorn recommends that the roadway be resurfaced with 3-4" of suitable surface gravel, superelevated to drain toward the south shoulder, and roller compacted. A ditch should also be created along this south shoulder to improve drainage.

West of the hairpin turn, where the road runs through a low, flat area for ~400 LF, the roadway should be reconstructed or raised 6-8" with strong crown established to improve drainage and elevate the roadway above the surrounding water table. Additionally, ledge removal is recommended at three areas totaling approximately 120 LF along the south and east of the road to improve positive drainage in the ditch.

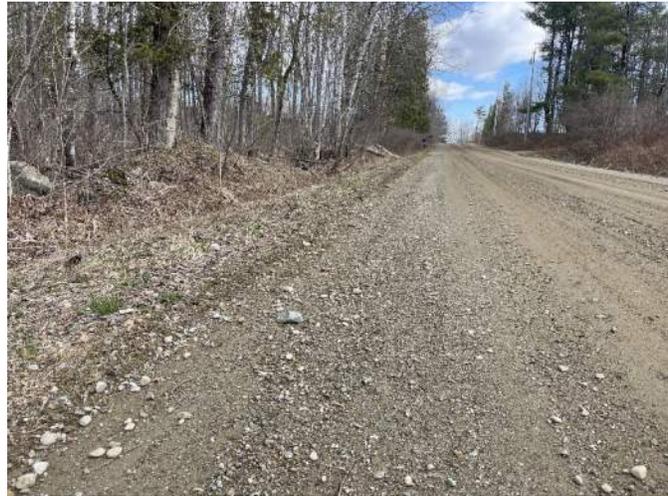
View along Choate Road, showing berm along shoulder

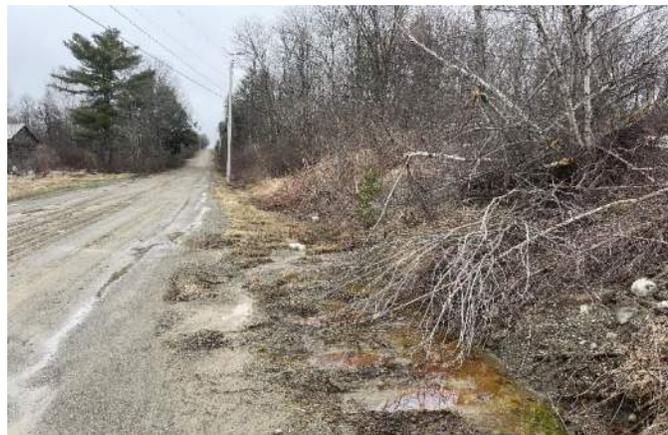
Standing water along Foy Road, looking east near Public Works/Route 220 intersection.

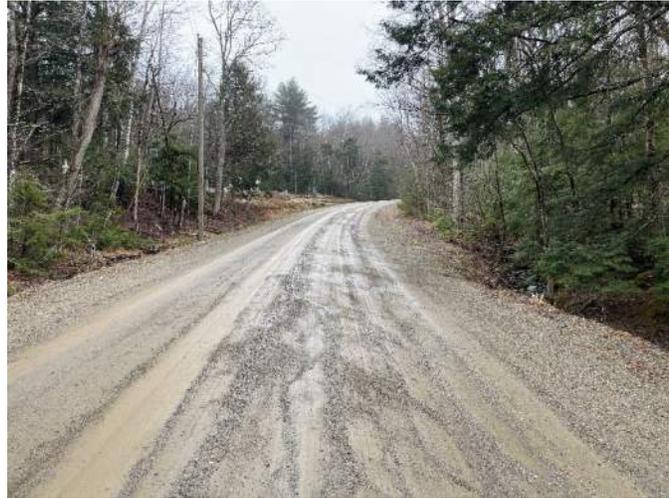
Halldale Road looking south at steep section. Shoulder erosion center right of photo.

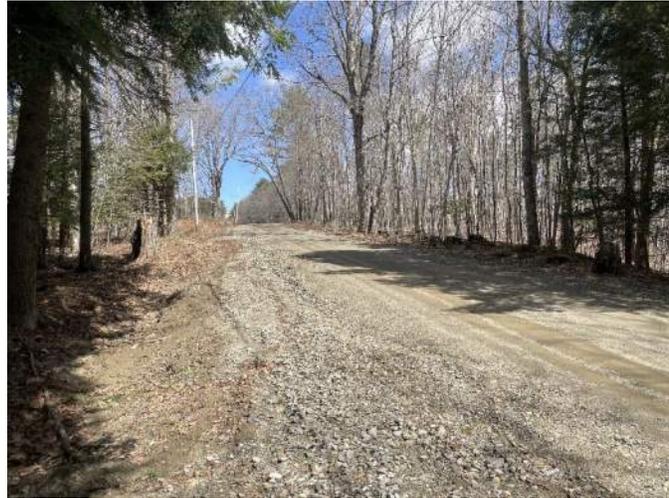
Hidden Valley Rd., looking north at eroded shoulder

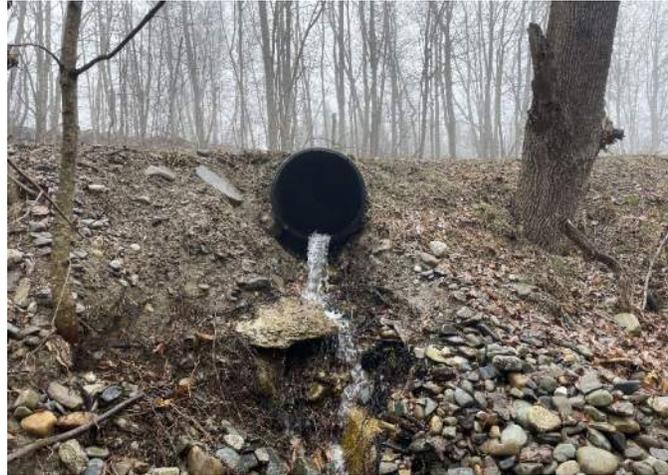
Perched culvert and outlet erosioint at Hogback Mountain Road, typ.

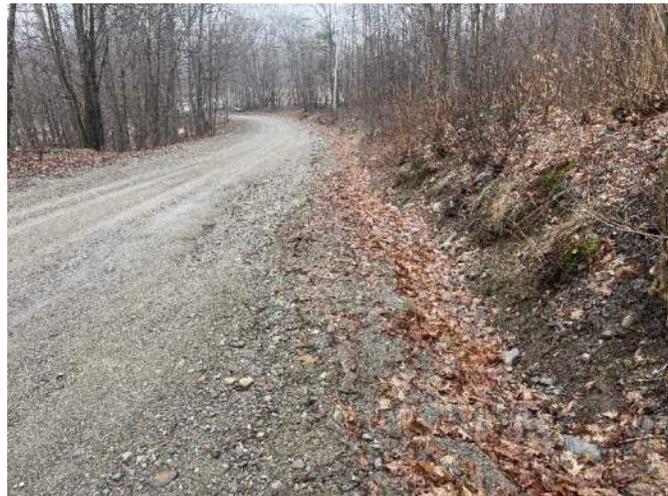
Limited ditch along Hogback Mountain Road downgradient of address #82 driveway.

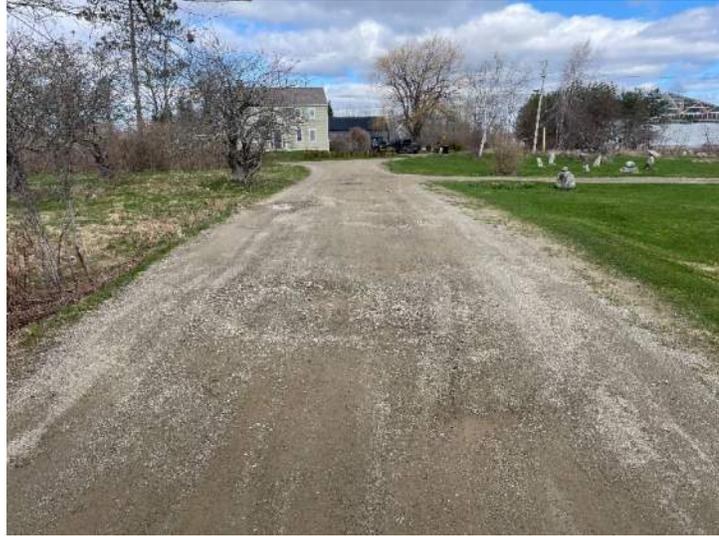
Jackson Road looking west toward the Choate Road intersection.

In general, Jackson Road is a primitive, single-lane road characterized by flat to rolling running slopes and has a flat cross-section; minimal crown or superelevation was observed at the time of inspection, and ditches were generally absent or shallow. Advanced potholes were observed in the first 200 LF of road, with the remainder of the road in generally fair condition and level with surrounding grade. Surface material has been pushed to the shoulders, creating a bermed shoulder and interrupting positive surface drainage.

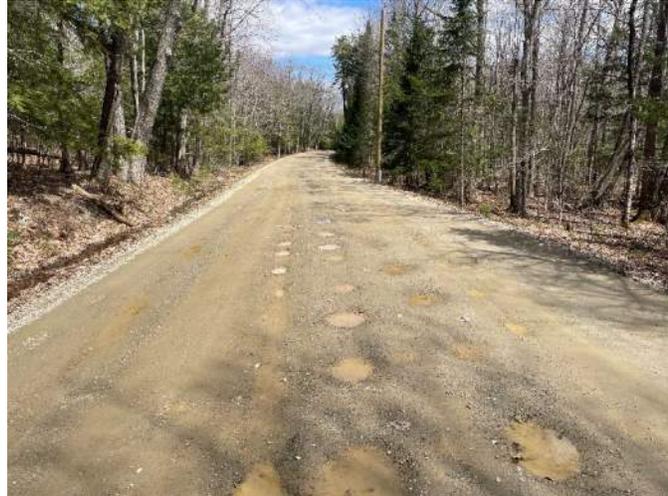
In general, the gravel portion of Morrill Road is characterized by flat to rolling running slopes and a flat roadway cross-section; minimal crown was observed at the time of inspection. Advanced potholes were observed along much of the road. Much of the roadway, which is wide, is elevated above surrounding grade or ditched, and ditches are generally shallow with woody growth. Surface material had been pushed to the shoulders and ditches, possibly during winter plowing activities. Additionally, it was evident that users travel this road at a high rate of speed, and potholes in the center of the road push drivers toward the edge of the road.

Morrill Road, typical condition

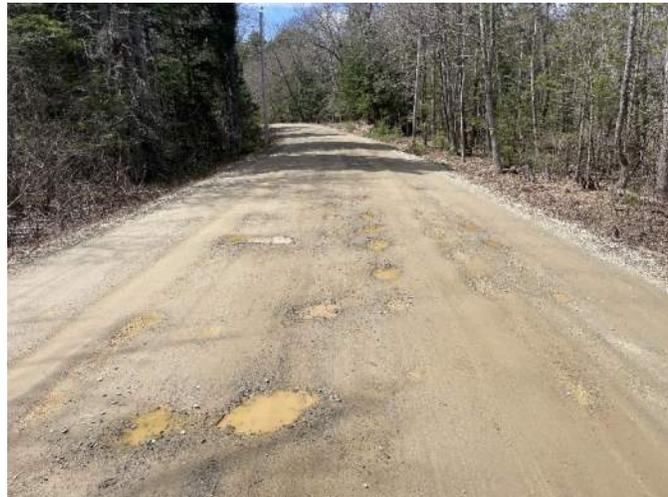
Morrill Road, typical condition

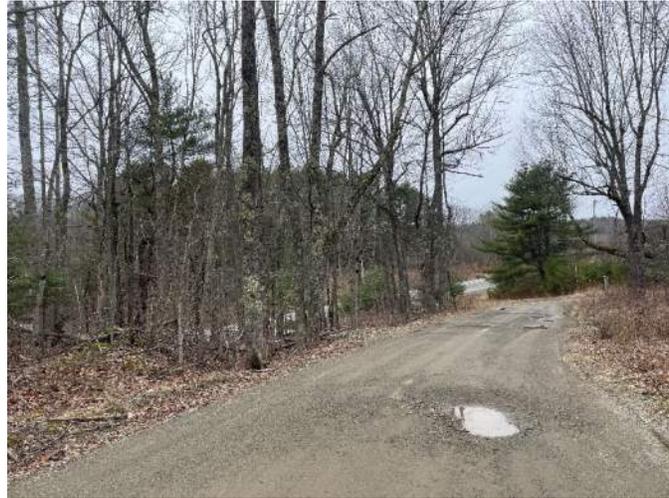
In general, New Ireland Road is characterized by flat to rolling running slopes and has a fair cross-section; crown and superelevation were observed at the time of inspection. Surface material has been pushed to the shoulders, creating a bermed shoulder and interrupting surface drainage. Potholes were observed within the first 0.1 miles, where the road cross section was the flattest. Elsewhere, ditching and drainage appeared adequate for the road's use.

New Ireland Road looking west, typical of first 0.1 mile

Regular grading, shoulder, and ditch maintenance should be conducted along New Ireland Road. Additionally, Acorn recommends that the first 0.1-miles of the roadway be resurfaced with 3-4" of suitable surface gravel, superelevated to drain to the south, and roller-compacted. Prior to resurfacing, the existing road should be scarified. It may be possible with a grader to salvage surfacing gravel which has been pushed into the shoulder to reduce material import.

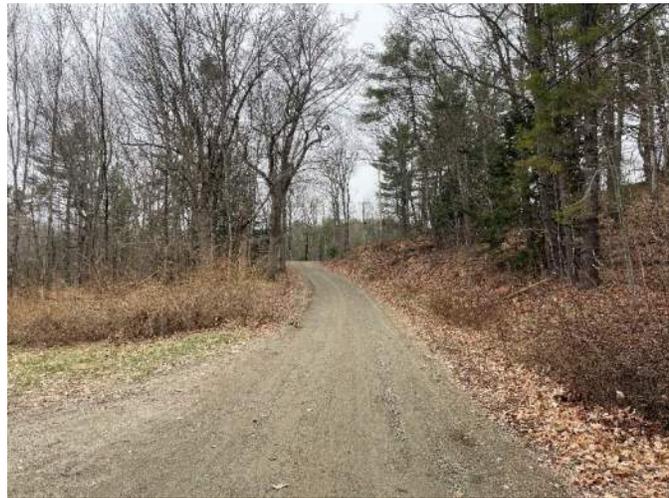
New Ireland Road looking southwest, typ.

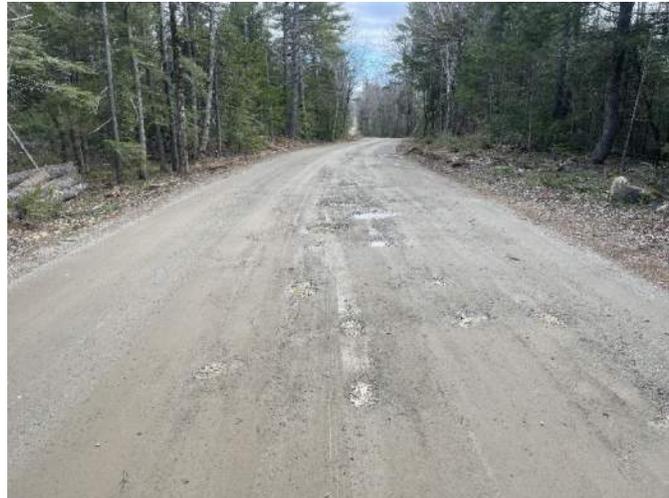
North Ridge Road is characterized by rolling to steep running slopes and a flat roadway cross-section, and minimal crown and ditching were observed at the time of inspection. Moderate ruts and potholes were observed at the time of inspection, particularly in the 1.5 miles south of Hannan Rd., which was generally more shaded. The road surface is wide; ditching was generally present but shallow and was interrupted by ledge outcrops in some areas. Additionally, it was evident that users travel this road at a high rate of speed, and potholes in the center of the road push drivers toward the edge of the road.

PASER rating: 3 (Fair)
Establish Crown: Yes
Potholes: 3 (Moderate)
Ruts: 3 (Moderate)
Clear ditch: Yes

North Ridge Road looking north, typical section

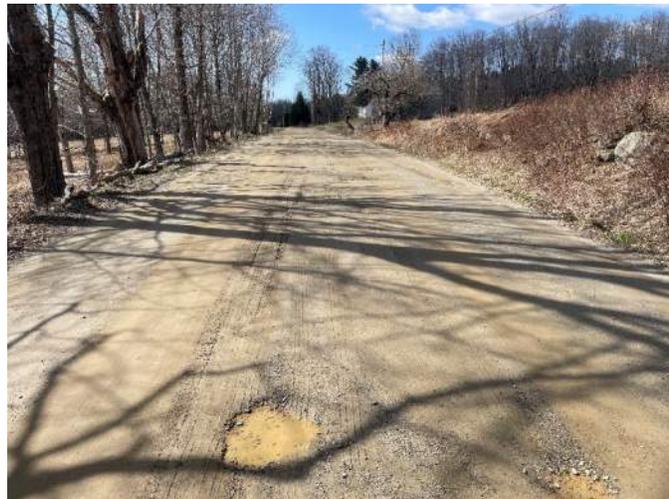
North Ridge Road looking south, typical section

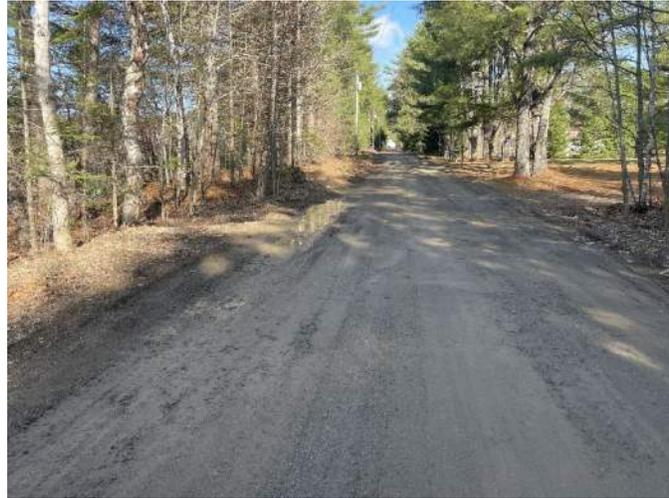
In general, North Trotting Park Road is characterized by flat to rolling running slopes and a flat roadway cross-section; minimal crown and ditching were observed at the time of inspection. Minor ruts and moderate potholes were observed. Numerous sections of road sit below existing grade, and shoulders were bermed. It was evident that surface material has been pushed to the shoulders over time and that water is held on the road surface.

PASER rating: 3 (Fair)
Establish Crown: Yes
Establish Ditch: Yes
Potholes: 3 (Moderate)
Ruts: 2 (Minor)

North Trotting Park Road looking west, typical condition

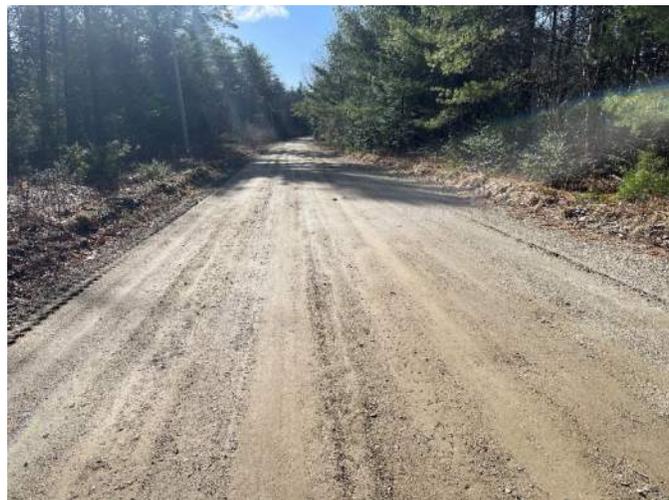
North Trotting Park Road looking east, typical condition

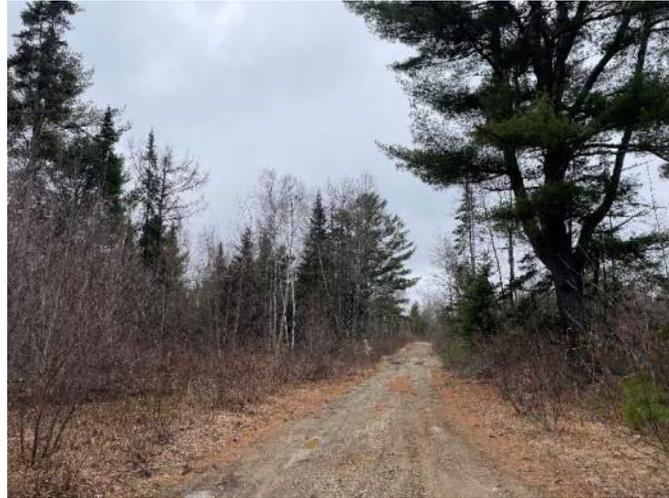
PASER rating: 1 (Failed)

Peavey Town Road, end section, typical condition where passable

As deemed appropriate or necessary by the Town, Peavey Town Road should be reconstructed with a full-depth gravel road profile to sit above existing grade, and be graded with positive crown or superelevation. If significant investment is not desired, areas of significant failure, totaling ~0.2 miles, may receive 6-8" of compacted surface gravel to facilitate emergency access.

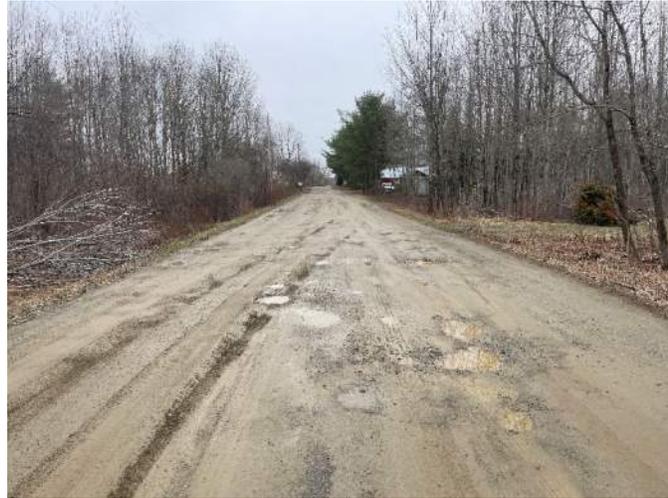
In general, this portion of Peavey Town Road is characterized by flat to rolling running slopes and a flat, wide roadway cross-section; minimal crown was observed at the time of inspection. Advanced potholes and minor ruts were observed along much of the road. Much of the roadway is elevated above surrounding grade or ditched, but ditches are generally shallow with woody growth. Surface material has been pushed to the shoulders and ditches, and some interruption of surface drainage was evident. Additionally, it was evident that potholes in the center of the road push drivers toward the edge of the road.

PASER rating: 2 (Poor)
Establish Crown: Yes
Establish Ditch: Yes
Potholes: 4 (Advanced)
Ruts: 1 (Minimal)

Peavey Town Road looking east, main section near Rt 220, typical condition

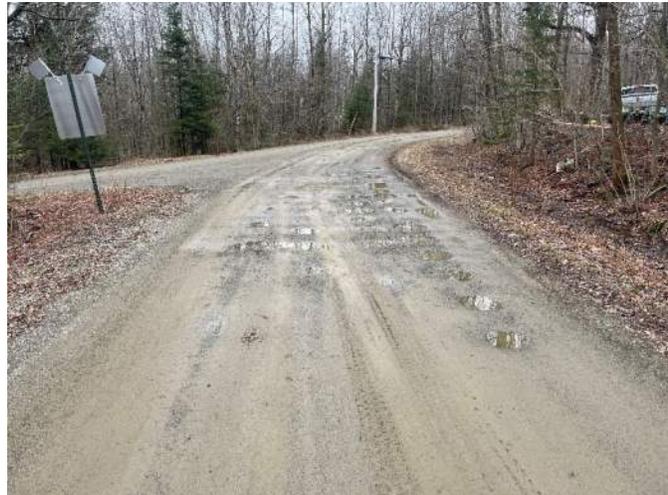
Peavey Town Road, main section, looking east at Twitchell Hill Rd. intersection2

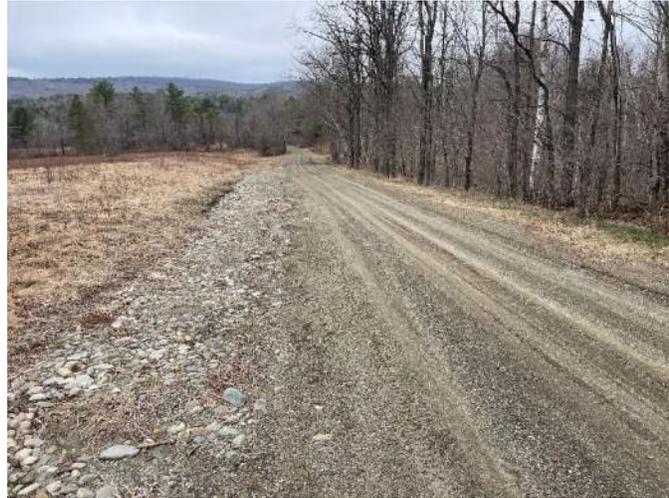
Peavey Town Road, middle section, looking northwest, shoulder erosion present

If investment is desired along this section of Peavey Town Road, light ditching to deepen the ditches north of address #238 may allow for more snow storage along this section of road and allow spring runoff to access the ditches, reducing road surface erosion. Overall, this section of road was in good condition, but recent ditching had not been stabilized and was highly susceptible to erosion. Whenever ditch maintenance is performed, exposed earth should be stabilized with vegetation, bark mulch, jute mat, or similar non-erosive cover material to protect the ditch invert and side slopes from erosion.

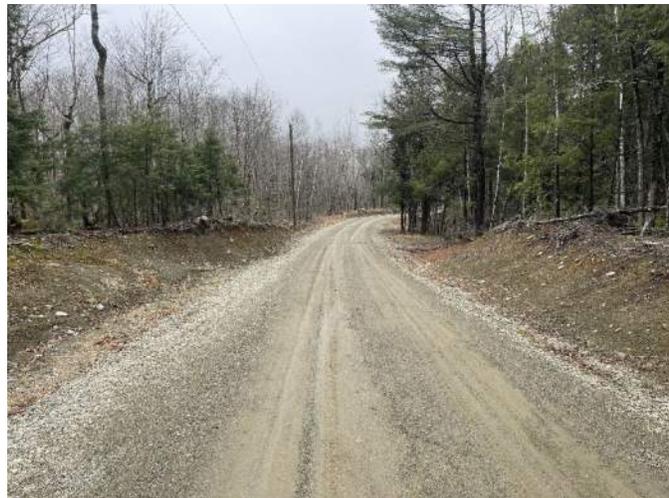
Peavey Town Road, middle section, looking northwest, recent ditching not stabilized

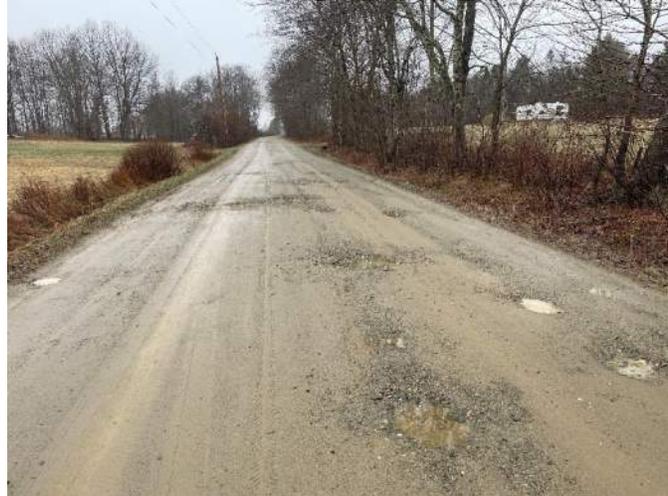
In general, Penney Road is characterized by flat to rolling running slopes and a flat roadway cross-section, and minimal crown or superelevation was observed at the time of inspection, especially closest to the intersection with Goosepecker Ridge Road. Moderate potholes and ruts were observed along much of the road. Much of the roadway is elevated above surrounding grade or ditched, but ditches are generally shallow with woody growth, and the road base appeared poorly-drained in some locations. Additionally, it was evident that potholes in the center of the road push drivers toward the edge of the road.

PASER rating: 3 (Fair)
Establish Crown: Yes
Erosion in Road: 2 (Minor)
Potholes: 3 (Moderate)

Penney Road looking north, typical condition

Penney Road should be regraded to establish a strong crown, and roller compacted. Ditch and shoulder maintenance should be conducted along the length of the road to clear and deepen the ditches, improving drainage and snow storage capacity. Particular attention should be paid to ditch capacity and snow maintenance along the field north of Grant Road, where it appeared that runoff from spring snowmelt could not access the ditch, and ran down the snowbank along the road, eroding the road surface. Ditching should be coordinated with culvert maintenance or replacement at approximately 2 culverts within the first 0.1-miles of road south of the Goosepecker Ridge Rd. intersection, where culvert elevations should be lowered to allow a deeper ditch and to reduce erosion and perching at the culvert outlets. Culvert inlets and outlets should be stabilized with angular riprap.

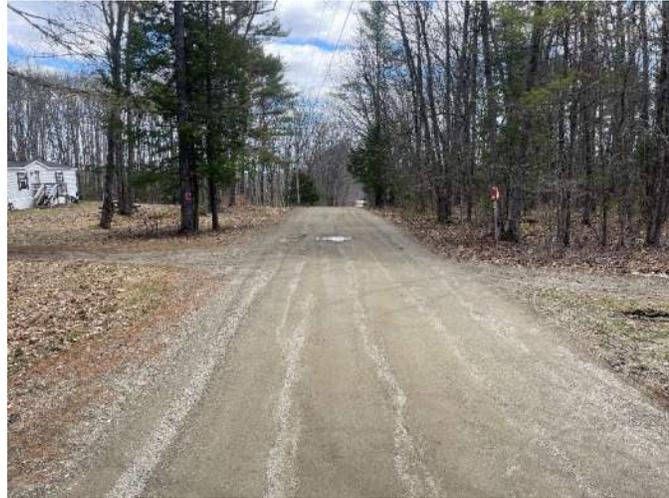
In general, Pierce Hill Road is characterized by rolling running slopes and has a fair cross-section; crown and superelevation were observed at the time of inspection. Surface material has been pushed to the shoulders along the westernmost 0.1 miles of road, which is generally constructed at grade with limited ditches. Potholes were observed within the westernmost 0.1 miles, where the road cross section was the flattest. Elsewhere, ditching and drainage appeared adequate for the road's use.

Pierce Hill Road looking east, typical view

Routine grading, shoulder, and ditch maintenance should be conducted along Pierce Hill Road. If investment is desired, the westernmost 0.1-miles of the roadway may be resurfaced with 3-4" of suitable surface gravel to bring the road surface above surrounding grade, crowned, and roller compacted. Prior to resurfacing, the existing road should be scarified to remove potholes. It may be possible with a grader to salvage surfacing gravel which has been pushed into the shoulder to reduce material import.

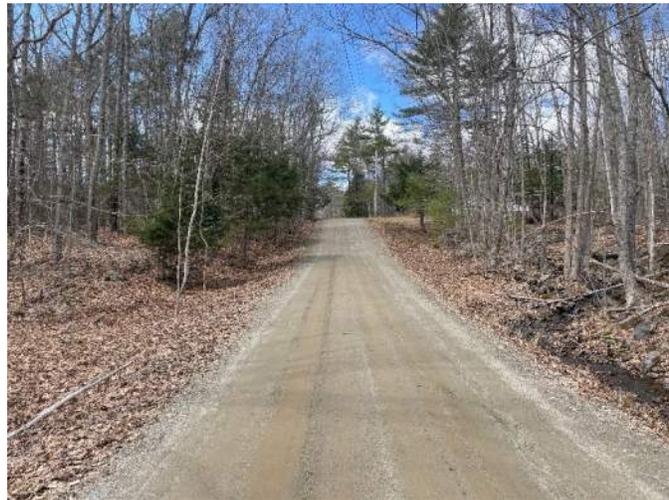
Pierce Hill Road looking west, typical view

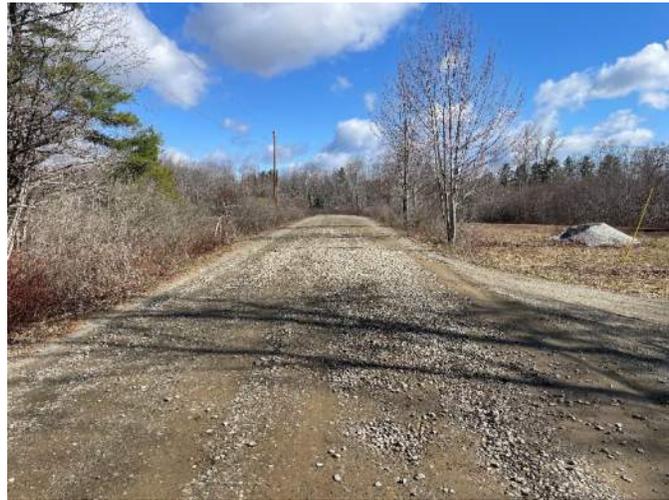
In general, Montville's portion of Prescott Hill Road is characterized by flat running slopes and a flat roadway cross-section, and minimal crown and ditching were observed at the time of inspection. Surface and base drainage appeared poor, with ditches dominated by woody vegetation at the time of inspection. Recent maintenance/surfacing with uniformly graded $\frac{3}{4}$ " bank run stone was observed at the time of inspection, and Acorn understands the maintenance was not performed by the Town of Montville. The new surfacing material was loose, and it was evident that older surfacing material has been pushed to the shoulders over time, possibly during winter plowing activities.

Prescott Hill Road looking north, typical condition

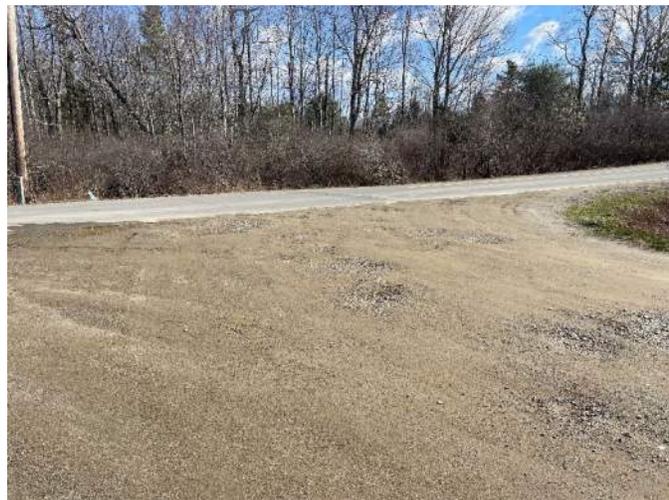
Prescott Hill Road looking northeast at intersection

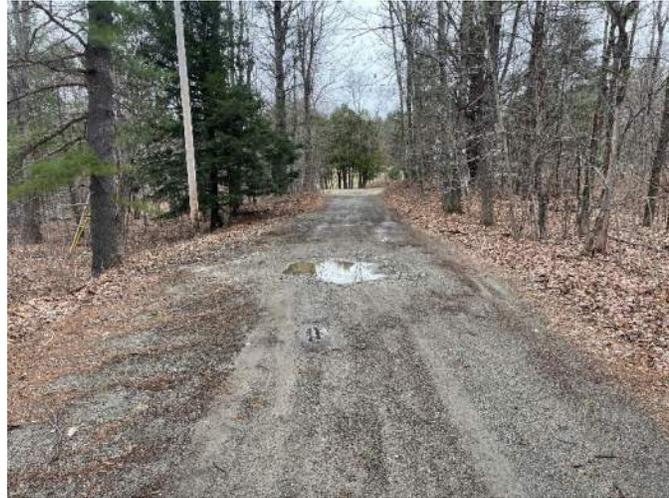
In general, Sewall Road is characterized by flat running slopes and a flat roadway cross-section, and minimal crown and ditching were observed at the time of inspection. The road sits at or below surrounding grade, and advanced potholes were observed at the time of inspection. The roadway was in a poor to failed condition at time of inspection.

PASER rating: 1 (Failed)
Establish Crown: Yes
Potholes: 4 (Advanced)
Roadway is trenched: Yes
Grade shoulders: Yes
Reconstruct: Yes
Clear ditch: Yes

Sewall Road looking north, typical condition

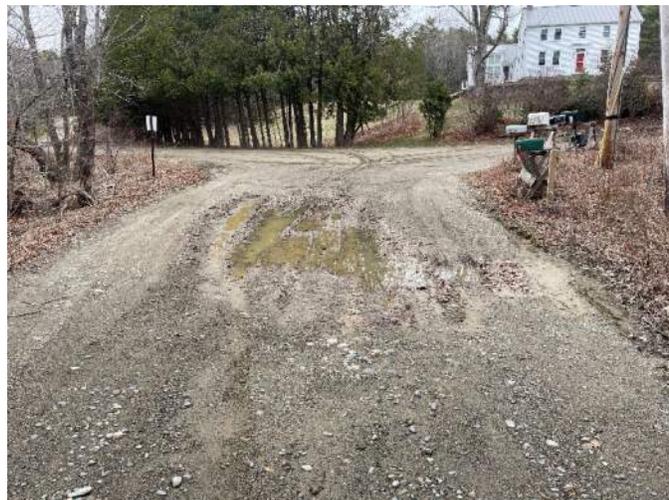
Sewall Road looking north at Kingdom Road intersection, typical condition

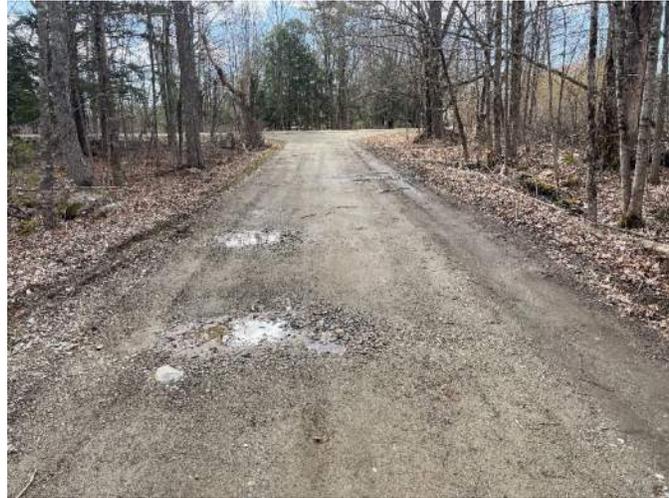
South Trotting Park Road is characterized by flat running slopes and a flat roadway cross-section, and minimal crown and ditching were observed at the time of inspection. The road sits at or below surrounding grade and minor potholes and moderate ruts were observed at the time of inspection. Ditching was generally absent, and where existing, shallow and vegetated, suggesting a saturated road base condition.

South Trotting Park Road looking south, typical condition

South Trotting Park Road should be resurfaced with 6-8" of suitable surface gravel to raise the roadway surface, superelevated to drain to the west, and roller compacted. If the Town and abutters are agreeable to a slightly narrower road condition, it may be possible to raise the road surface elevation slightly by salvaging gravel from the wider road profile to reduce material import. A ditch should be established along the west side of the road to drain the road base and outletted into a stabilized ditch runout/turnout north of the address #19 home driveway.

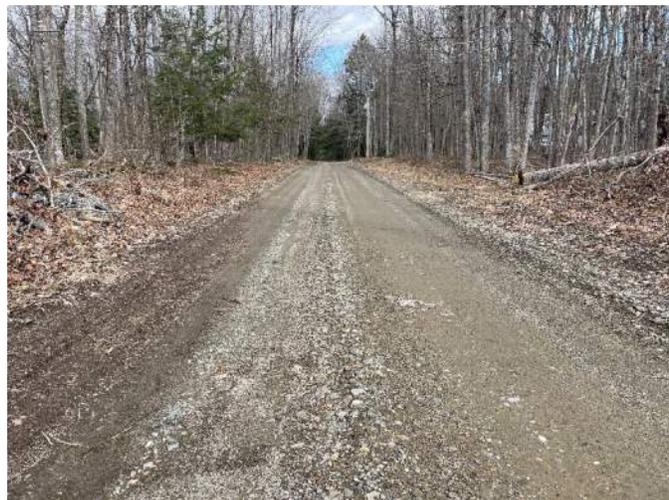
South Trotting Park Road looking north, typical condition

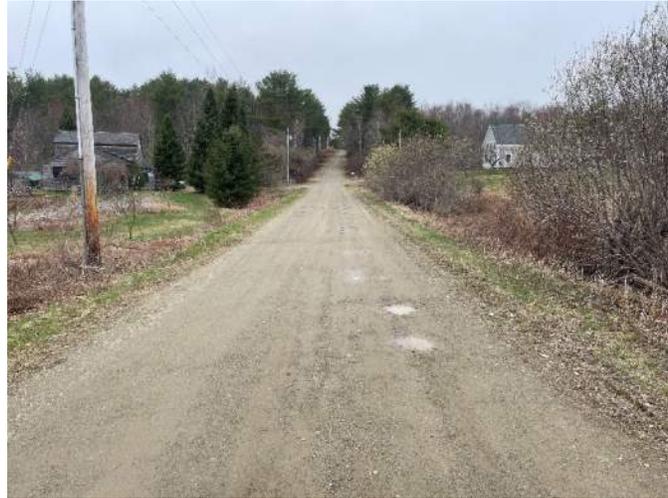
Spring Hill Road is characterized by flat to rolling running slopes and a flat roadway cross-section; minimal crown and ditching were observed at the time of inspection. Moderate potholes and minimal ruts were observed at the time of inspection, and the westernmost 0.2 miles of road were wide with poor surface drainage. Ditching was fair along the eastern 0.2 miles of road, although vegetated, and was generally well-drained. Shoulders were bermed in some areas, with evidence that surface material has been pushed to the shoulders over time.

Spring Hill Road looking west near dead end

The western 0.2 miles of Spring Hill Road should be resurfaced with 3-4" of suitable surface gravel, crown established, and the surface roller compacted. The existing road surface should be scarified to remove potholes prior to resurfacing. The western 0.2 miles of the road are wide and may be narrowed as deemed appropriate by the Town, and salvaging road material may reduce the need for material import along this western 0.2 mile length. Along the entire length of road, routine ditch maintenance should be conducted to reestablish, clear, and deepen ditches. Bermed material along the shoulders should be removed, and shoulders should be maintained to allow water to drain off the roadway surface and away from the road base.

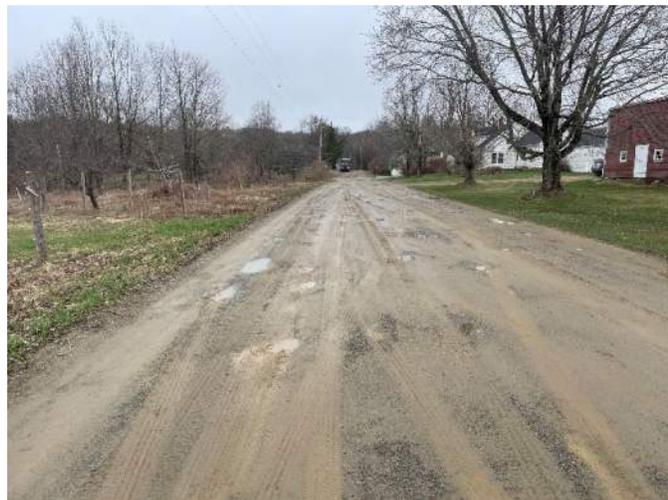
Spring Hill Road looking west near Route 220 intersection

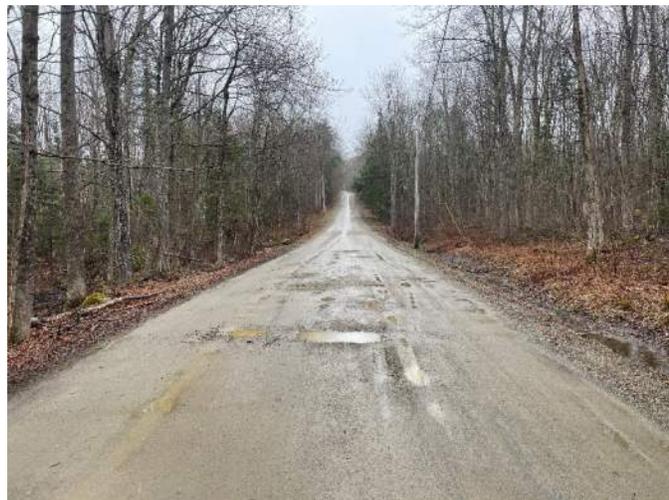
The main section of Stewart Road is characterized by flat to rolling running slopes and a flat roadway cross-section; minimal crown and shallow ditching were observed at the time of inspection. Minor potholes and minimal ruts were observed at the time of inspection, and longitudinal erosion along the road surface was observed at the steepest climb, suggesting that snowmelt could not access the ditches during thaw. Shoulders were bermed in some areas, and the 0.15 miles closest to Morse Road were wide, with evidence that surface material has been pushed toward the shoulders over time.

Stewart Road looking west toward Morse Road

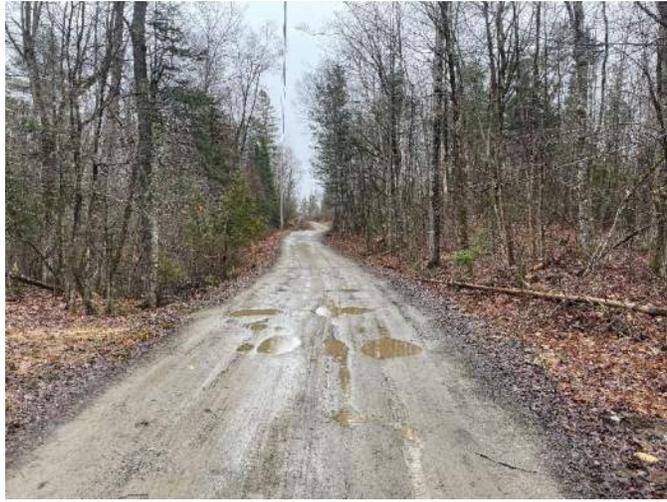
In general, the end 0.14 miles of Stewart Road understood by the Town to be their maintenance responsibility is an unimproved, primitive single-lane road, and is not easily traversable by low-clearance vehicles. The road sits at or below surrounding grade, with ditches absent and surface drainage poor.

Stewart Road, end section, facing east

PASER rating: 1 (Failed)
Establish Ditch: Yes
Erosion in Road: 2(Minor)
Potholes: 5 (Excessive)
Ruts: 3 (Moderate)

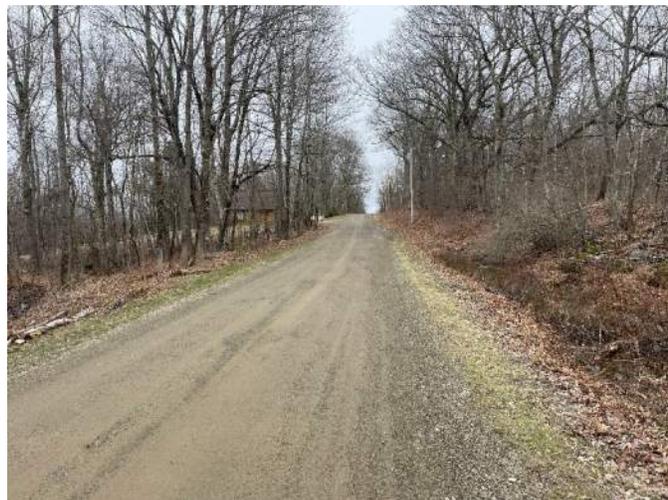
Thompson Road is characterized by flat to rolling running slopes and a flat roadway cross-section, and minimal crown or superelevation was observed at the time of inspection, especially closest to the intersection Route 3, where numerous potholes were observed. In general, ditches were moderately vegetated and shallow, and it was evident that surface material had been pushed to the shoulders over time, possibly during winter plowing activities.

Thompson Road looking east

It is recommended that routine ditch maintenance be conducted on Thompson Road to remove vegetation, and that a strong crown be reestablished to improve surface drainage. Some ditching may require coordination with electrical and telecom utilities, as some utility poles lie within the existing run of the ditch. Additionally, Acorn recommends that approximately 100 LF roadway at the Route 3 intersection be resurfaced with 3-4" of suitable surface gravel, superelevated to drain northeast, and roller-compacted. Along the entire length of road, bermed material along the shoulders should be removed, and shoulders should be graded to allow water to drain off the roadway surface and away from the road base. It may be possible with a grader to salvage surfacing gravel which has been pushed into the shoulder to reduce material import.

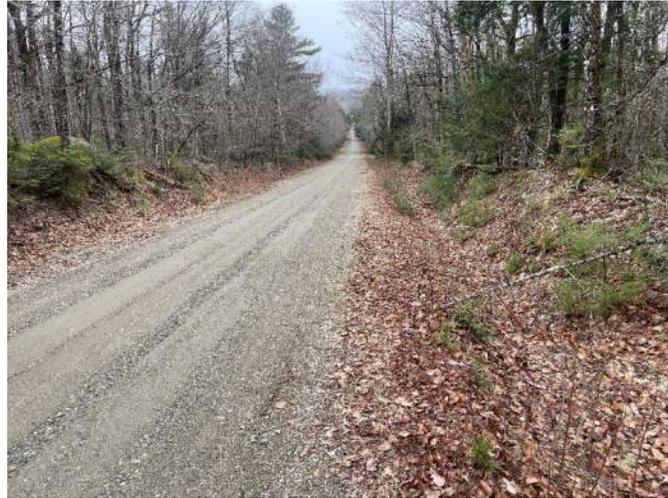
In general, the main section of Twitchell Hill Road is characterized by flat to steep running slopes and a flat roadway cross-section, and minimal crown was observed at the time of inspection. Moderate potholes and minor ruts were observed along much of the road, and some longitudinal erosion was observed on the road surface. Much of the roadway was elevated above surrounding grade or ditched, but ditches were generally shallow with woody growth. Additionally, it was evident that surface material has been pushed to the shoulders, possibly during winter plowing activities.

PASER rating: 3 (Fair)
Establish Ditch: Yes
Erosion in Road: 2(Minor)
Potholes: 3 (Moderate)

Twitchell Hill Road, main section, looking south

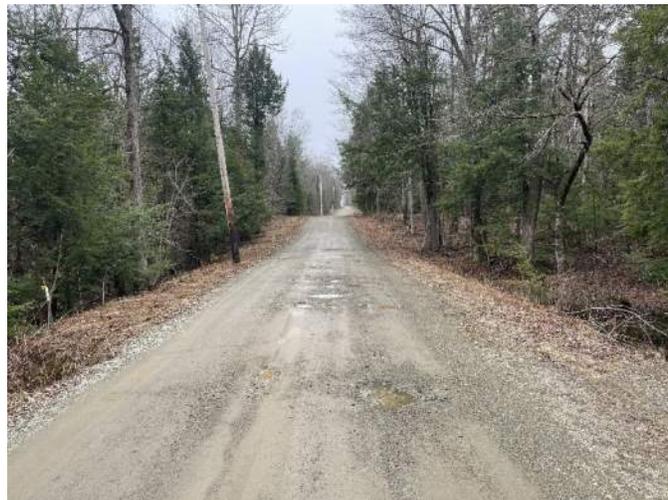
Twitchell Hill Road, main section, looking north

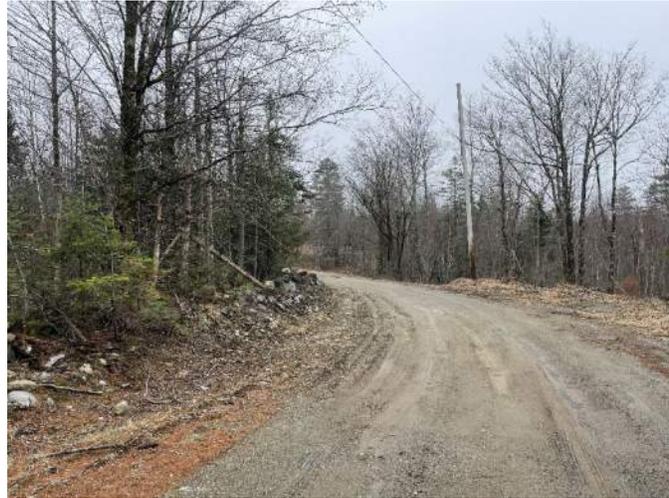
In general, the end 0.51 miles of Twitchell Hill Road is an unimproved, primitive single-lane road, and was not easily traversable by low-clearance vehicles at the time of inspection. The road sits at or below surrounding grade, with ditches absent, advanced ruts and potholes present, surface and base drainage poor, and native silty clays comprising the road base in some areas. Some recent gravel placement and light ditching were observed.

Twitchell Hill Road, end section, typical view at recent ditching

PASER rating: 1 (Failed)
Establish Crown: Yes
Establish Ditch: Yes
Potholes: 5 (Advanced)

Per Town and resident discretion, the end of Twitchell Hill Road should be reconstructed along its length to bring the roadway surface above existing grade, provide a stable, well-drained gravel base, provide positive surface drainage, and improve emergency vehicle access. The road surface should be superelevated, primarily toward the southeast, and a ditch should be created along the east shoulder of the road, which may require ledge removal in some areas. If limited investment is desired by the Town, the road may be spot repaired by reconstructing approximately 0.1 miles of road in select low areas of poor native soil. In all other areas, the road should be resurfaced with 3-4" of suitable surface gravel, compacted, and superelevated to drain toward the north. In all low, soft areas, poorly-drained native soils should be removed prior to reconstruction.
